21. MIDWOOD POOL BRIDGE

INTRODUCTION

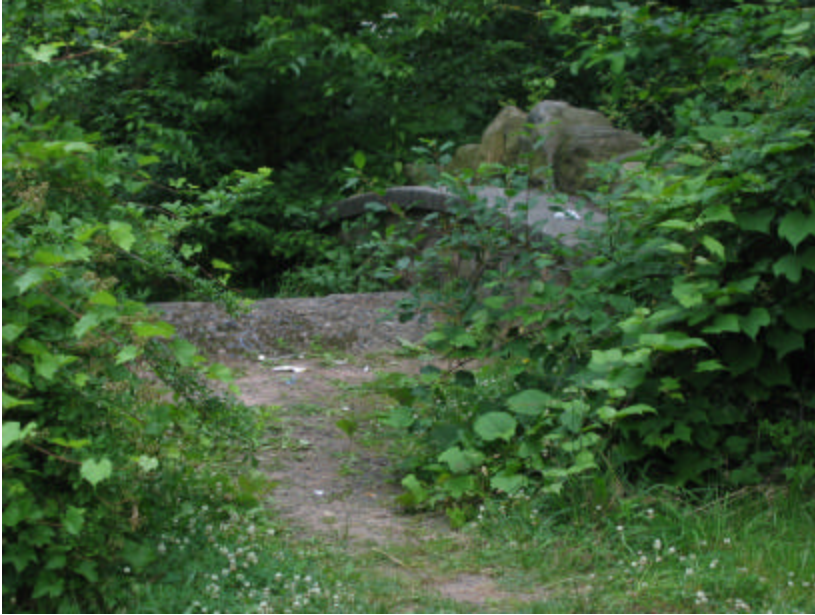
Photo 178
View east towards the Midwood Pool Bridge; note the vegetation including, trees, bushes and vines overgrowing the site.

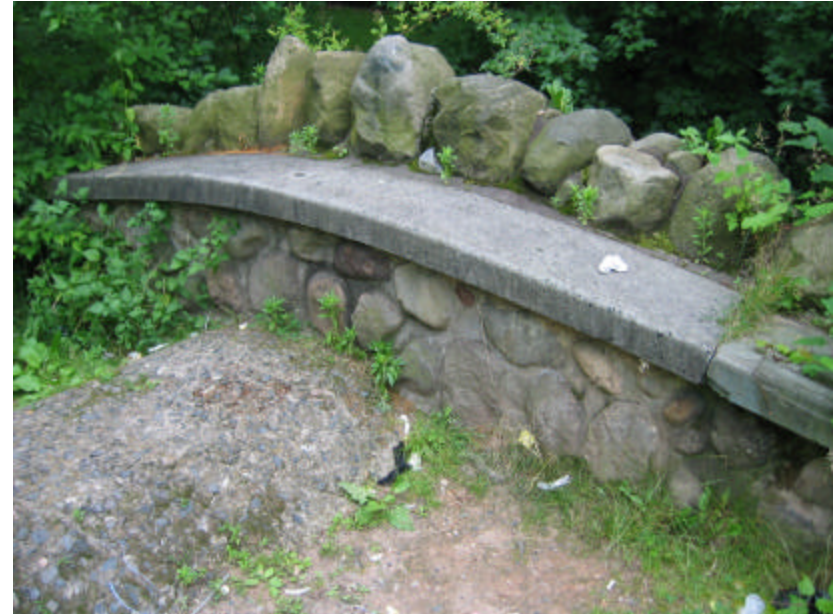
Photo 181
The south side of the bridge showing the built-in bench and concrete arch; note that a large section of the bench in this photo has been replaced by concrete and that the bluestone in the lower right corner is cracked.

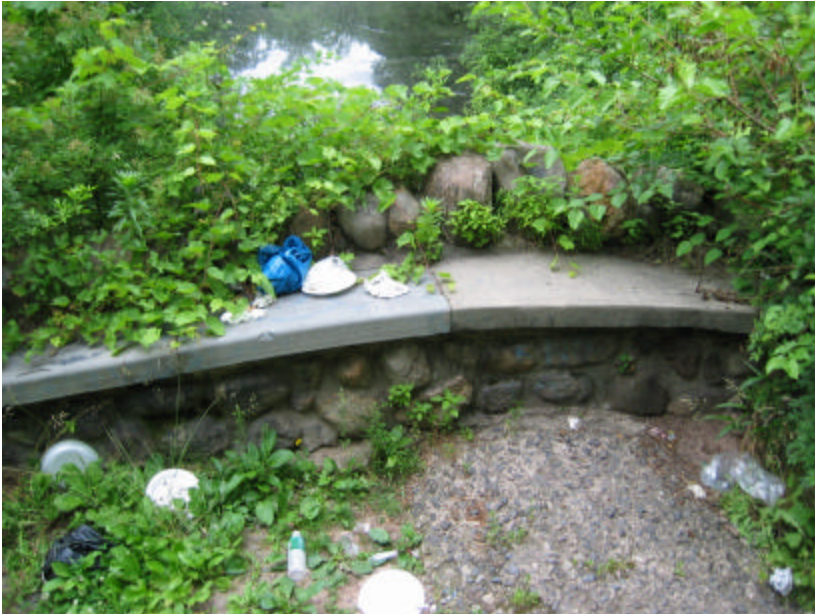
Photo 182
The north side of the bridge and built-in bench; note the vegetation and garbage covering the path and bench.

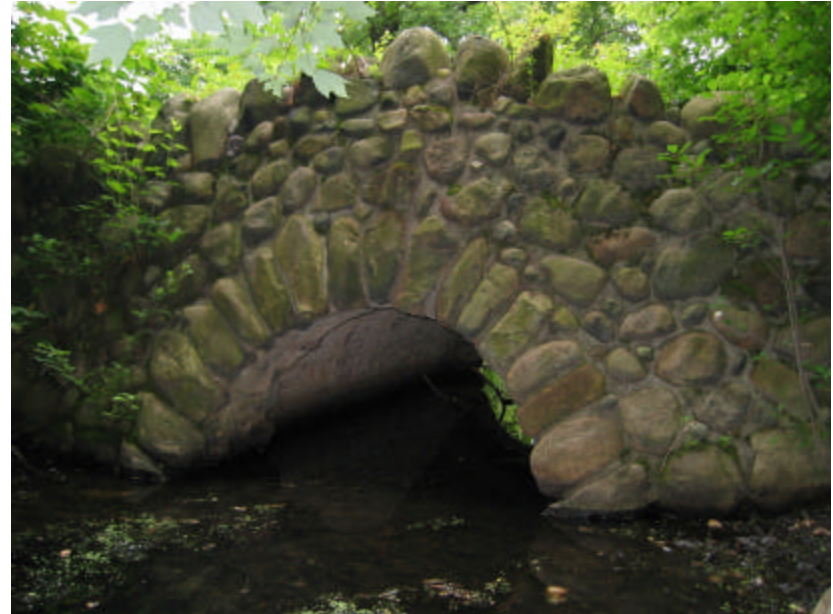
Photo 183
The vertical face of the south cheek wall; note the rustic fieldstone design of the bridge and concrete arch.

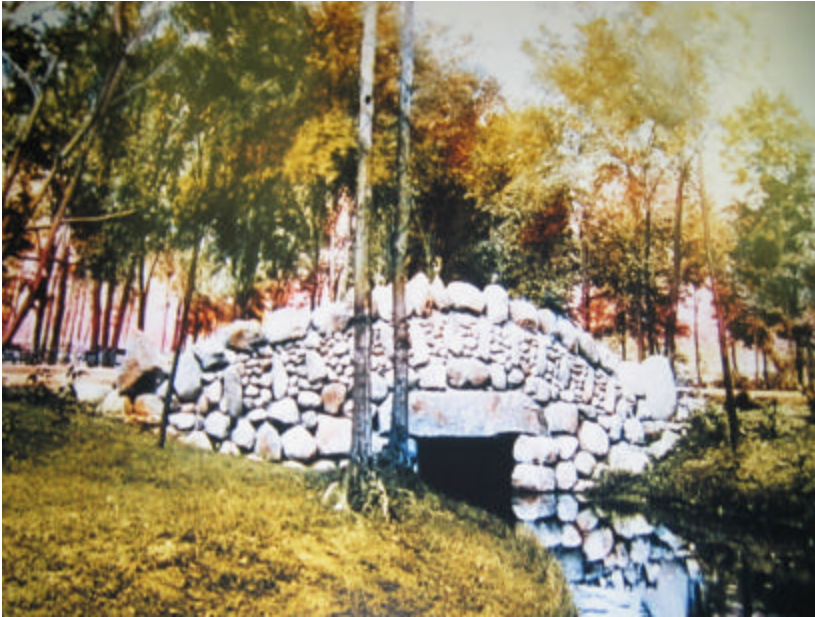
Historic Image 4
A hand colored photograph of the Midwood Drive Bridge around 1900; note the limited plantings and number of stones exposed at the channel.

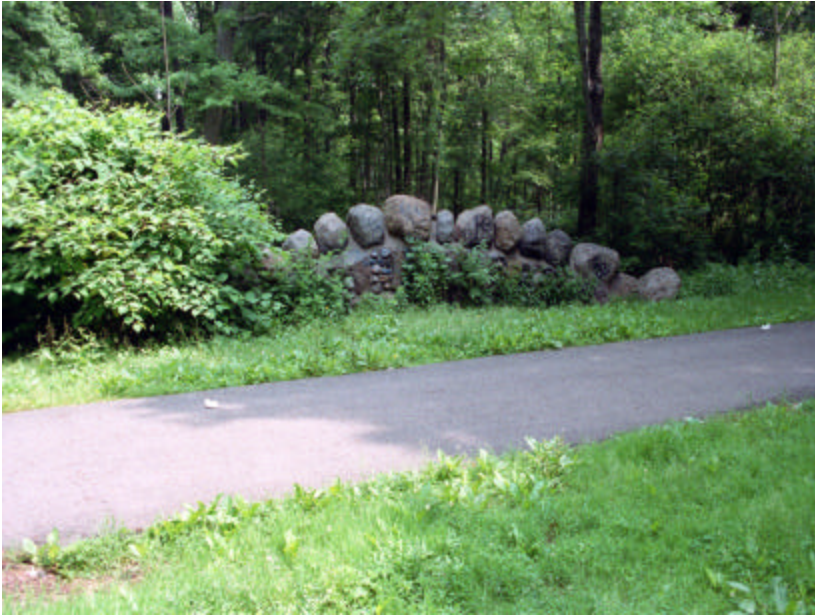
Photo 185
Asphalt path and grass-covered areas between the cheek walls; note the width of the bridge and the good condition of the pathway.

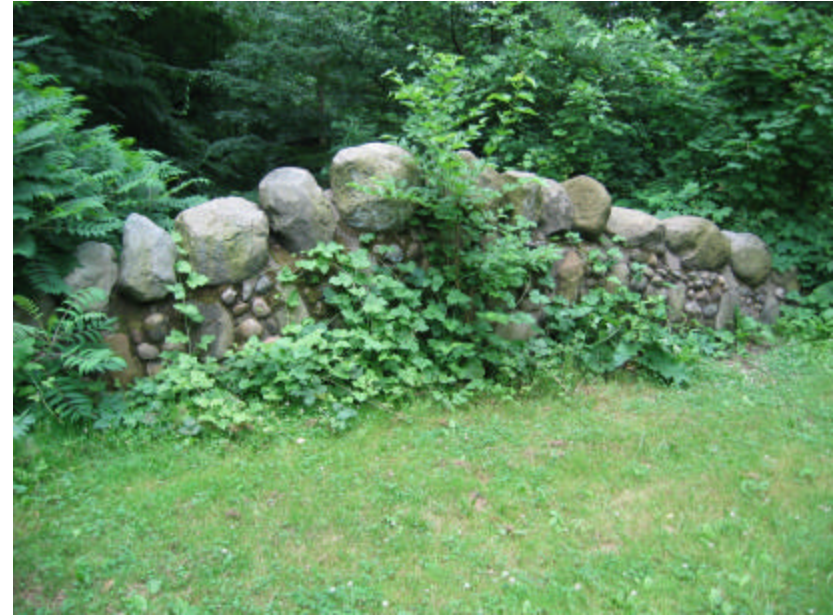
Photo 186
The south cheek wall of the bridge; note that plants are growing over most of the fieldstones.

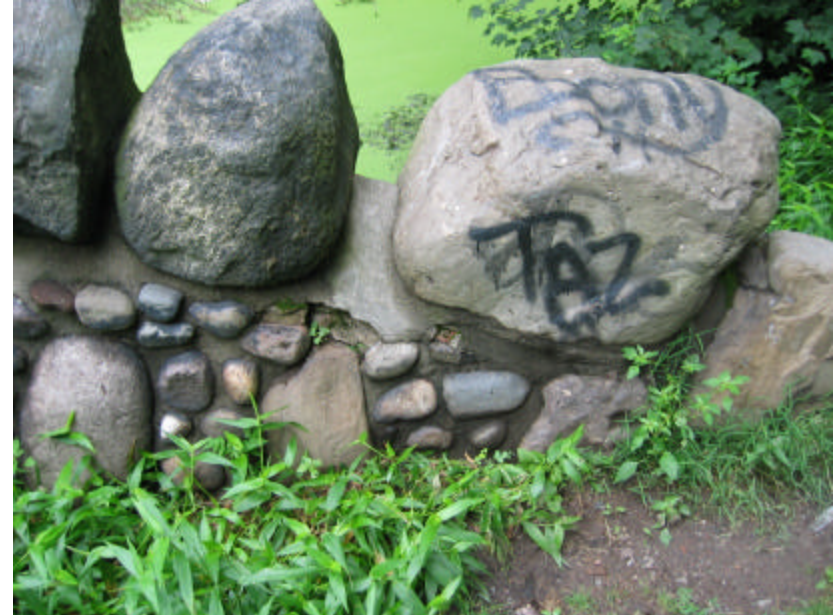
Photo 192
Visible signs of graffiti, erosion and spalled, cracked mortar on the north cheek wall.

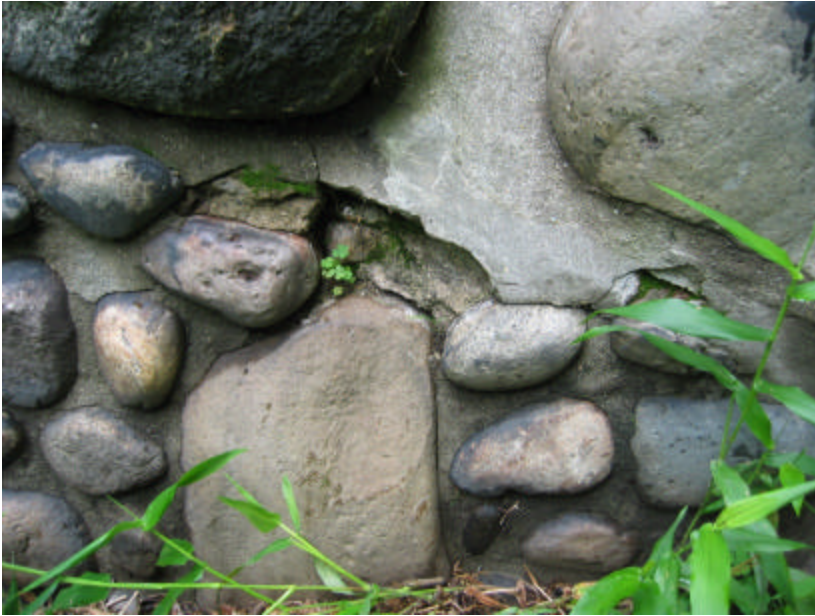
Photo 193
Cracked mortar along the north cheek wall; note the width of the mortar joints.

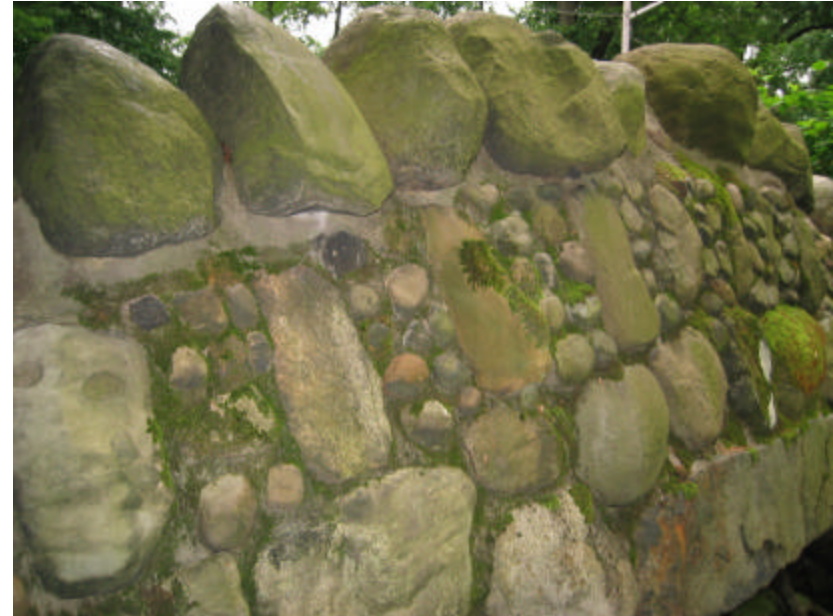
Photo 194
The vertical face of the north cheek wall; note the moss growing on the fieldstone and mortar surfaces.

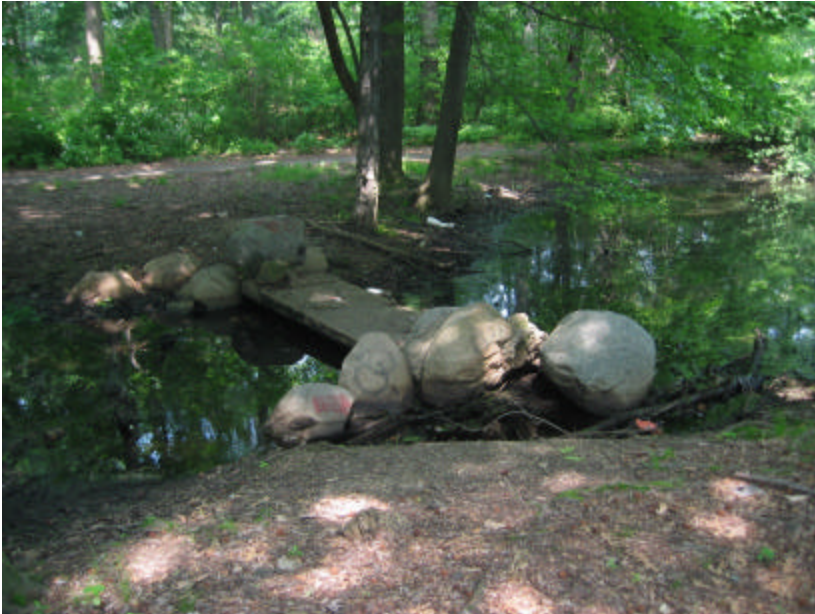
Photo 195
Weir 2 is constructed from concrete and has boulders set into concrete on each side.

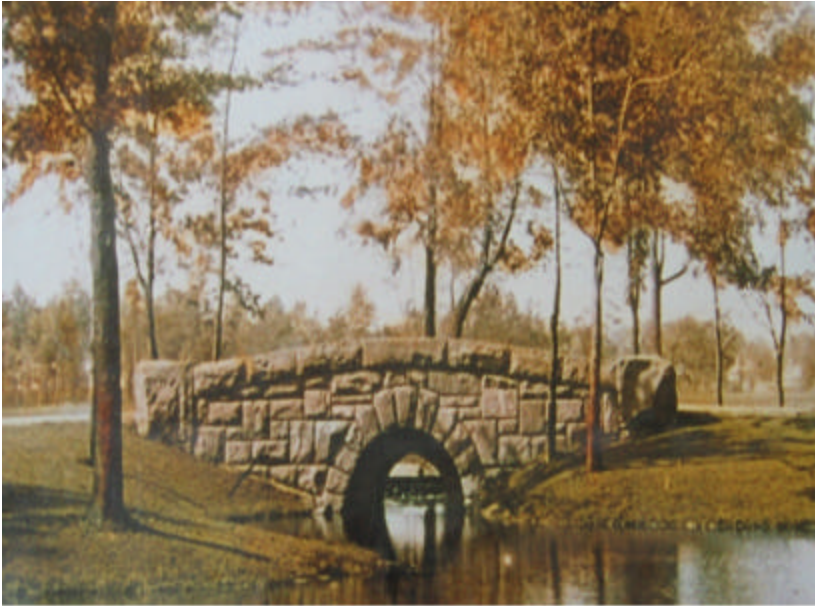
Historic Image 5
This hand colored photograph, circa 1900, is from the collection of Essex County Parks.

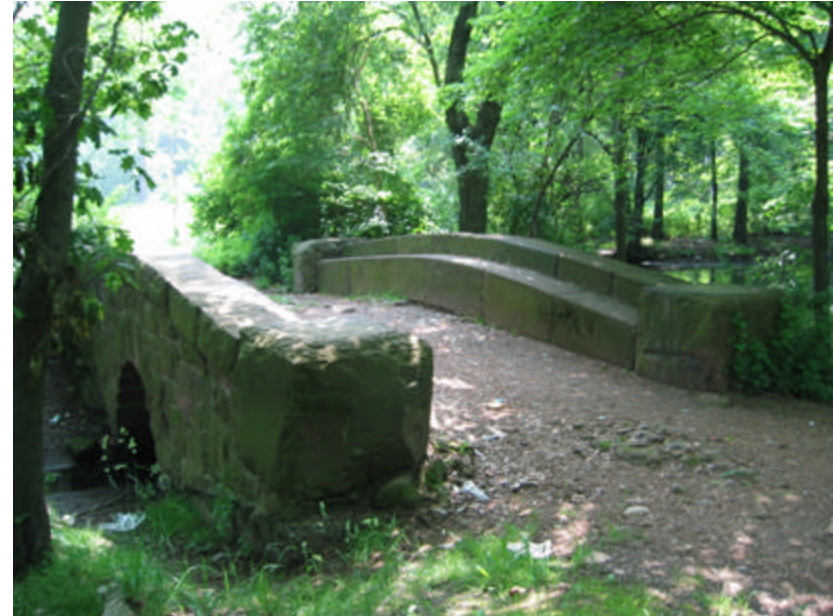
Photo 198
View looking east over the Brownstone Bench Bridge; note the rough and uneven condition of the bridge's deck.

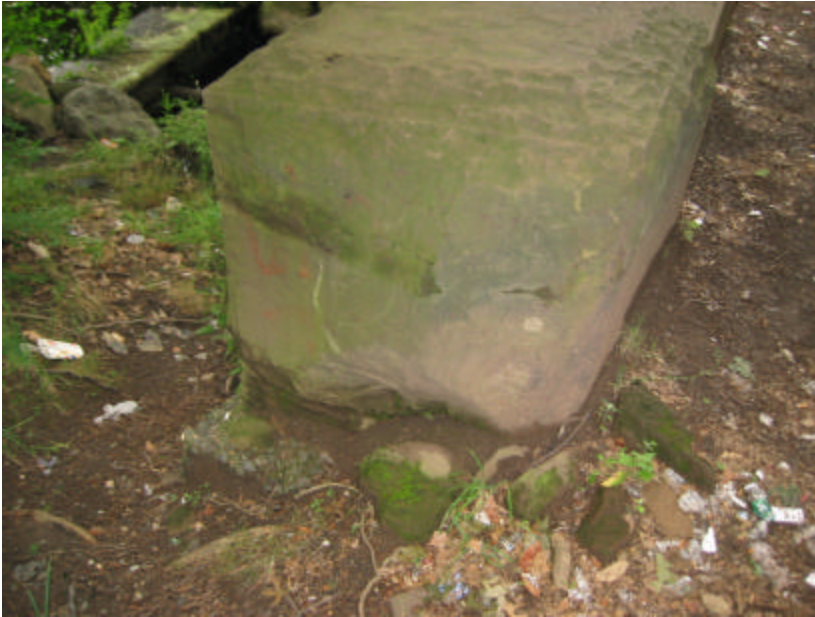
Photo 199
One of the large brownstone blocks at the west end of the north cheek Wall; note the exposed concrete foundation, and the rocks and roots suggesting significant water runoff causing erosion.

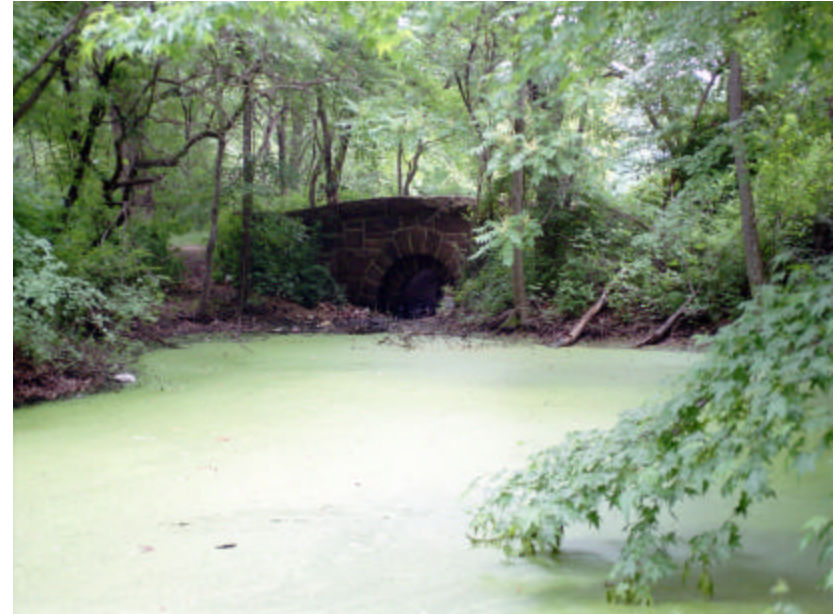
Photo 200
The brownstone bench bridge north of the Edgewood pool.

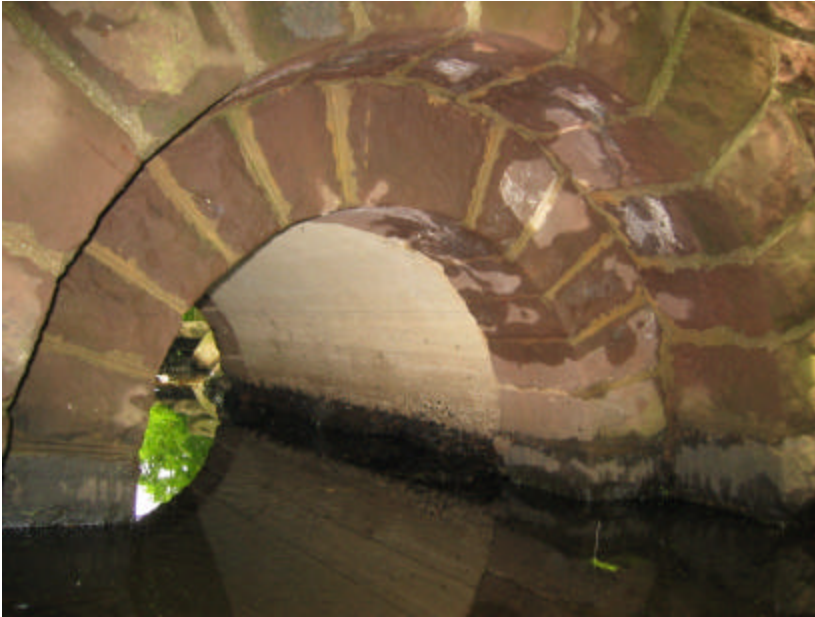
Photo 201
The two brownstone arches on the south side of the bridge; note the efflorescence and water staining of the brownstone blocks.

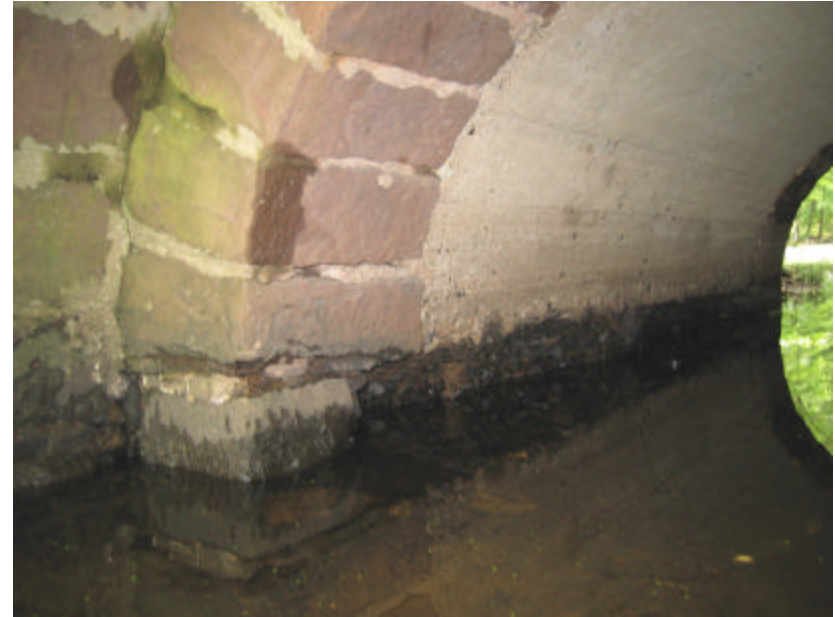
Photo 202
The brownstone arches and concrete archway under the bridge; note the significant erosion of the brownstone blocks, mortar joints and the concrete arch.

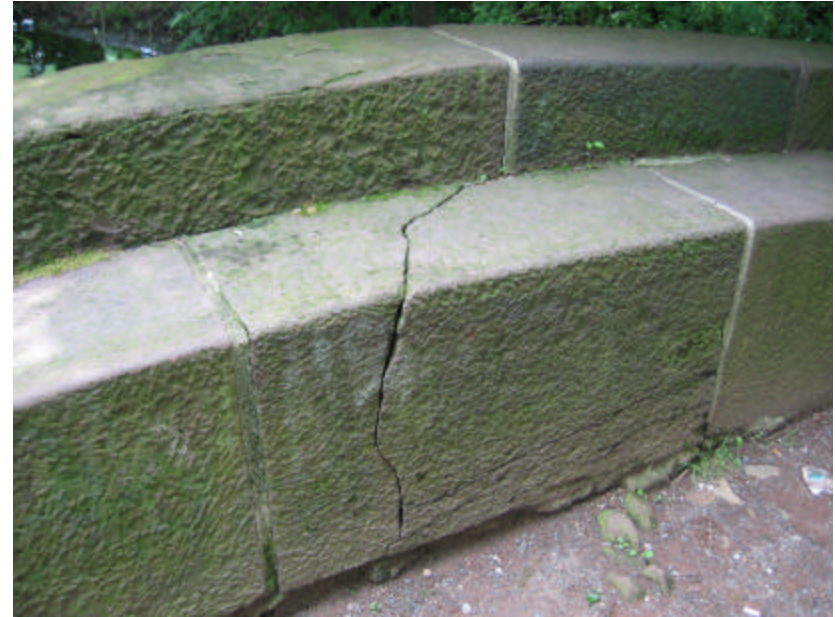
Photo 204
This large crack, approximately 3/8" wide, goes entirely through the brownstone block; note the eroded mortar joints, brownstone and soil at the base of the block.

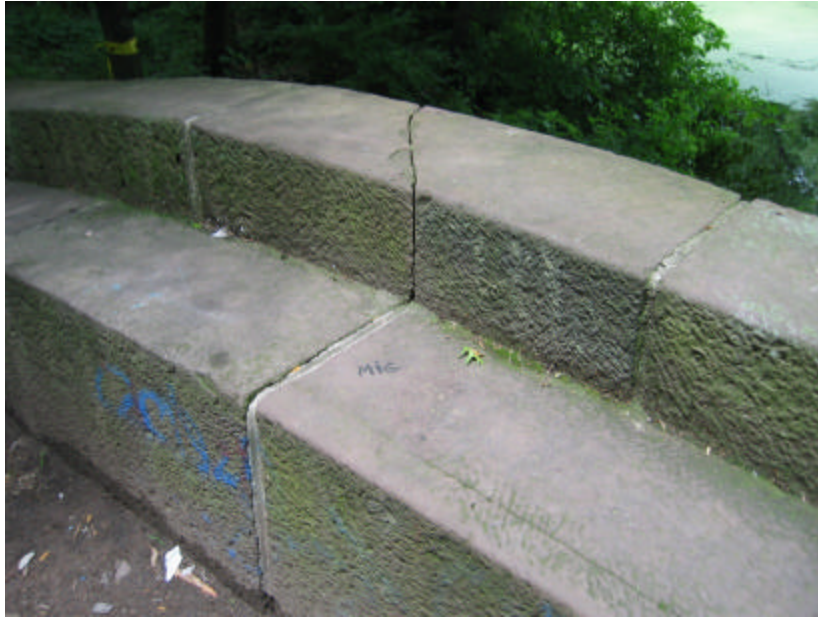
Photo 205
This copingstone is cracked in half; note how the crack matches up with the open and exposed mortar joint on the bench, suggesting that cracking may have been exacerbated by water infiltration and freeze-thaw cycles.

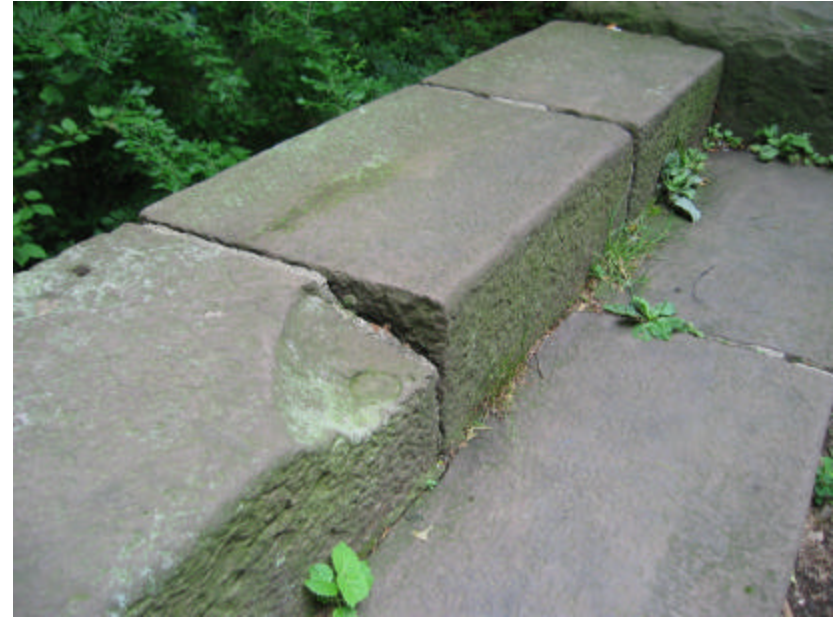
Photo 206
Significant spalling on the corner of a copingstone; note the open and exposed mortar joints with plants growing out of most of them.

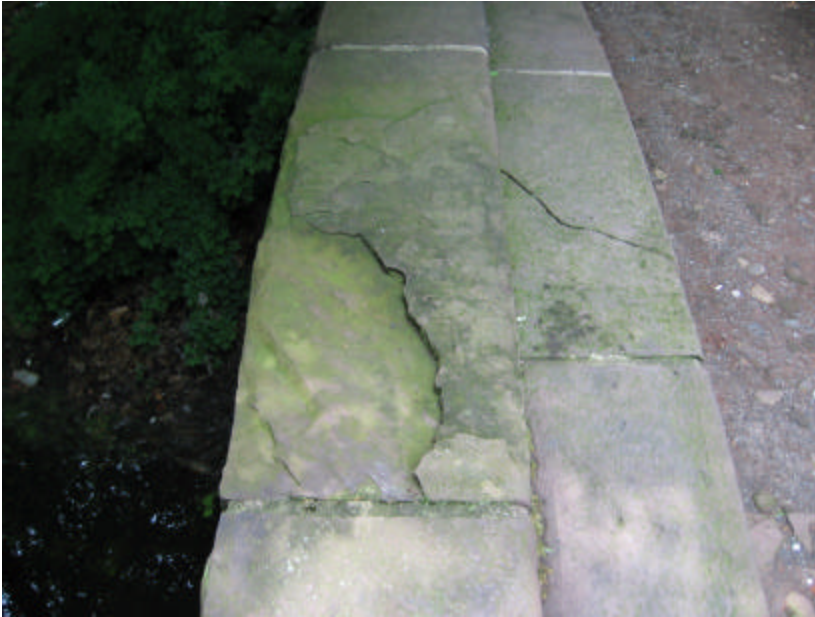
Photo 207
Spalling and delaminating of brownstone on the south copingstones of the bridge; note that cracking and delaminating occurs along the bedding planes of the brownstone.

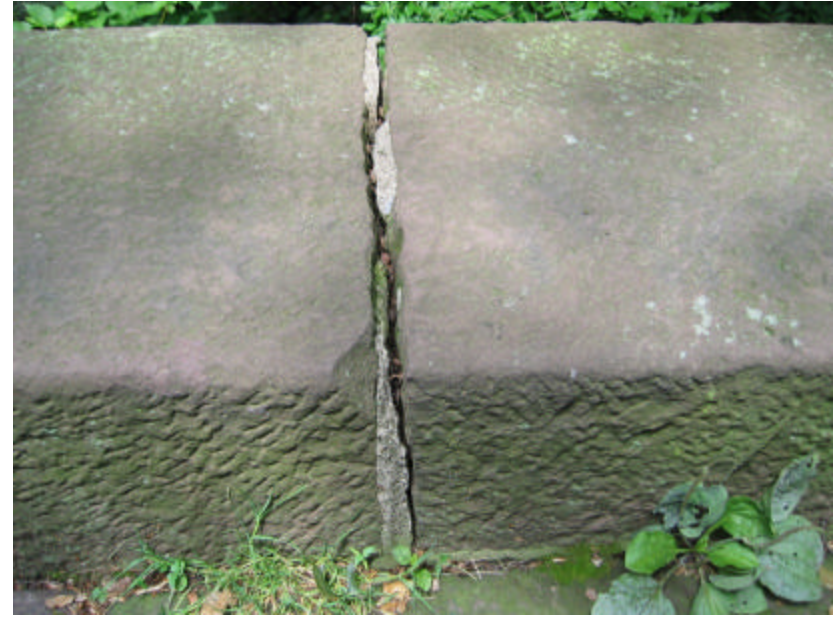
Photo 208
An open and exposed mortar joint between two copingstones at the top of the cheek wall; note the spalling along the edges of the stone and the significant amount of missing mortar.

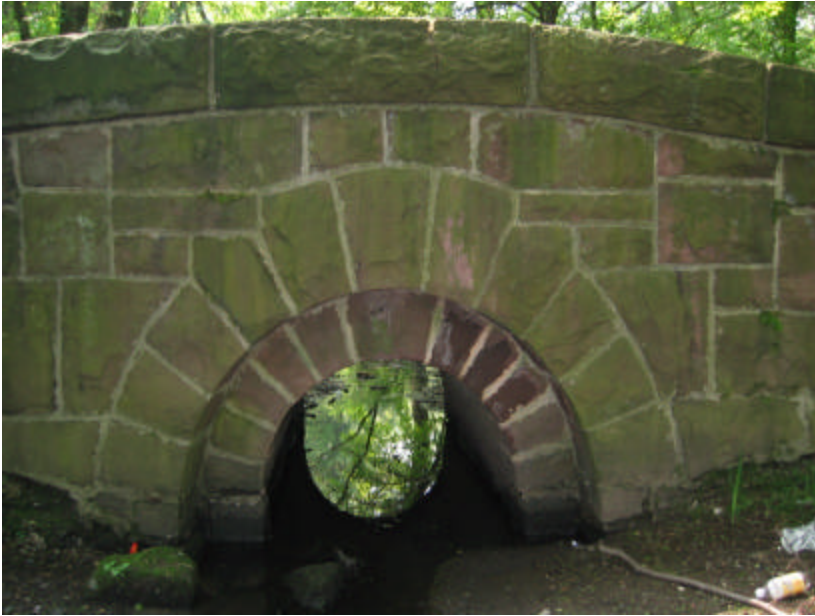
Photo 209
The rough-cut, random ashlar stonework on the south side of the bridge; note the varying types of mortar used in the joints; note that only 11 whole stones are visible along the arch.

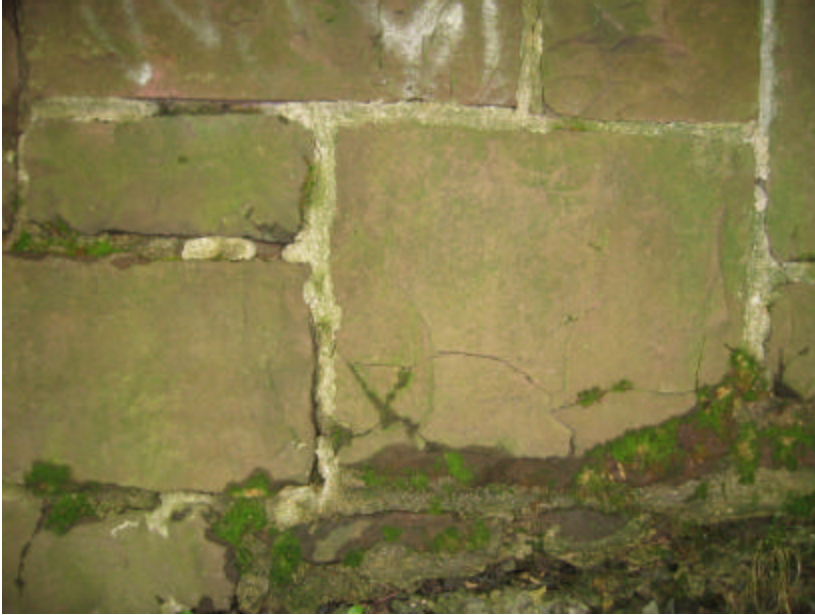
Photo 211
Spalling and cracking stone at the base of the north cheek wall;
note the organic growth at the bottom of the photograph.

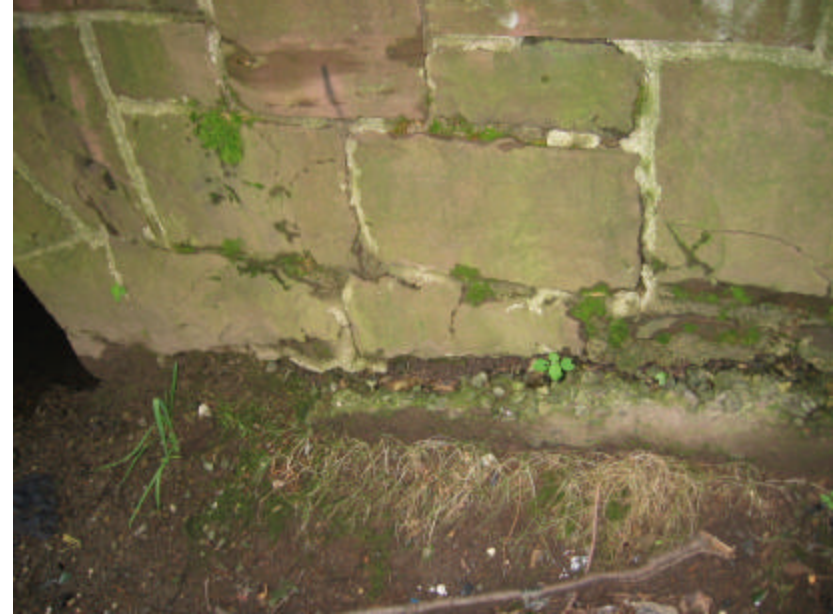
Photo 212
Cracked and eroded concrete foundation at the base of the north
cheek wall.

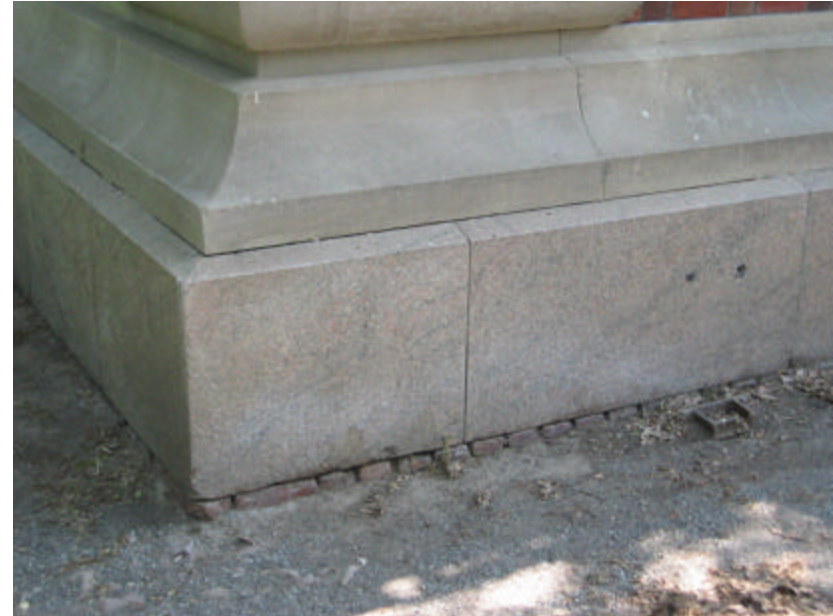
Photo 217
The southwest corner of the north pavilion; note the open and exposed joints of the brick foundation.

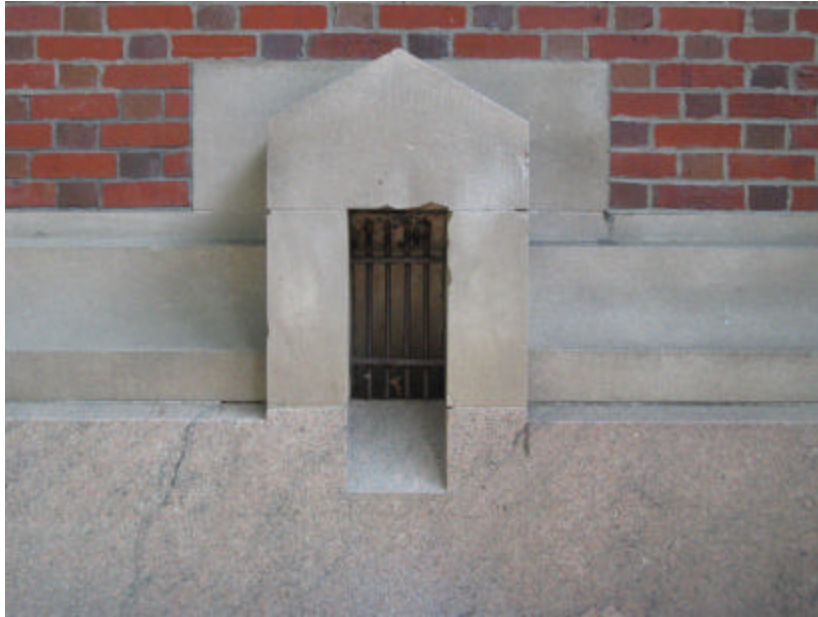
Photo 218
The pedimented limestone vent on the south wall of the north pavilion;
note the spalling of the stone.

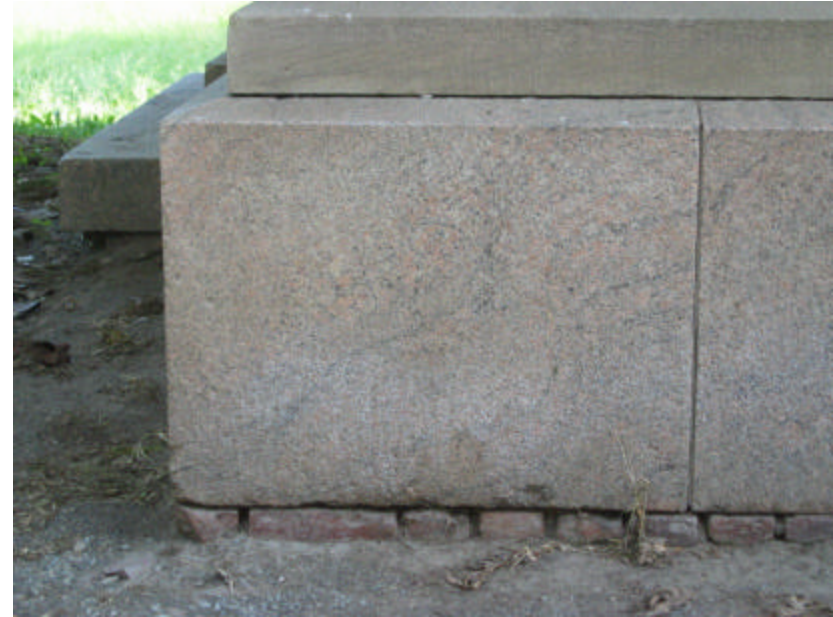
Photo 219
Granite plinth resting on the brick foundation; note the open vertical
and bed joints of the granite and limestone.

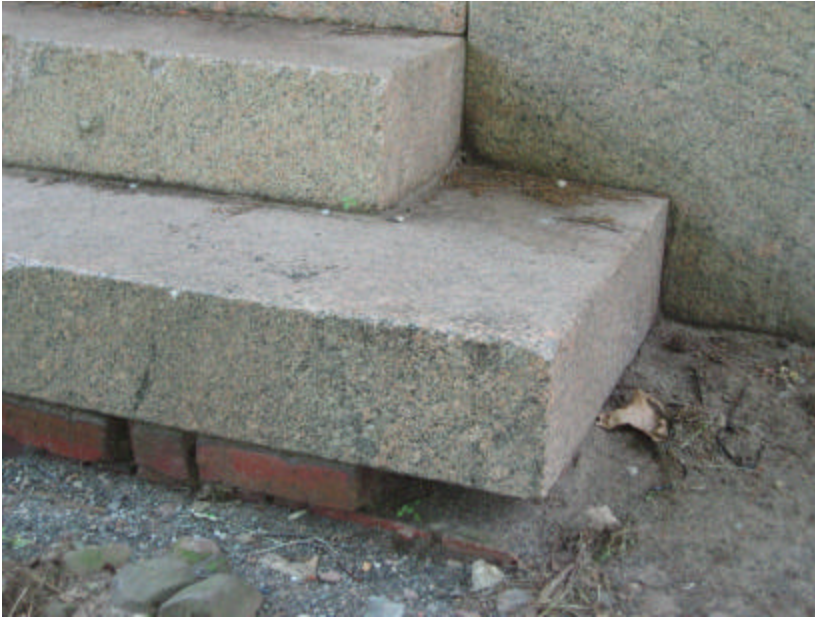
Photo 220
The granite stoop on the west façade of the north pavilion; note the missing brick and the deeply eroded joints.

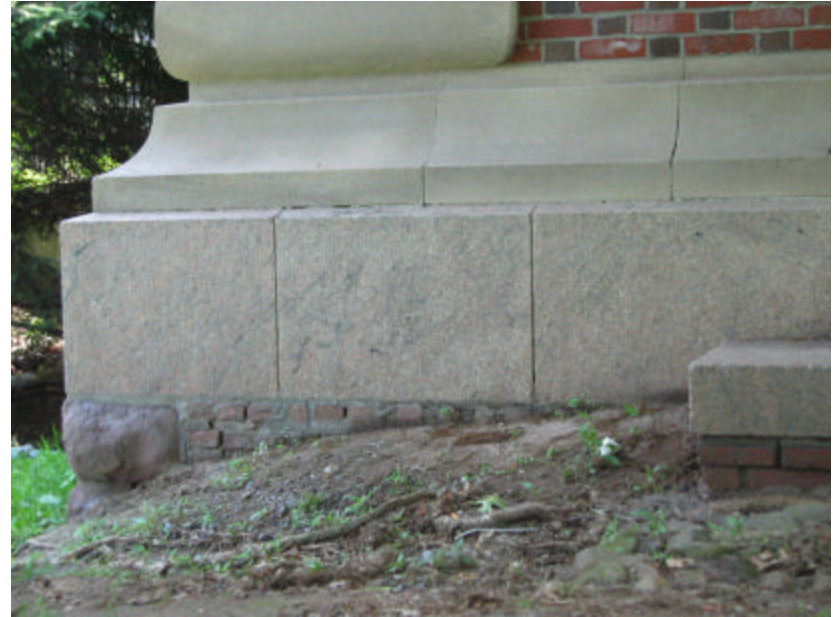
Photo 221
The soil has eroded considerably around the site exposing the foundation.

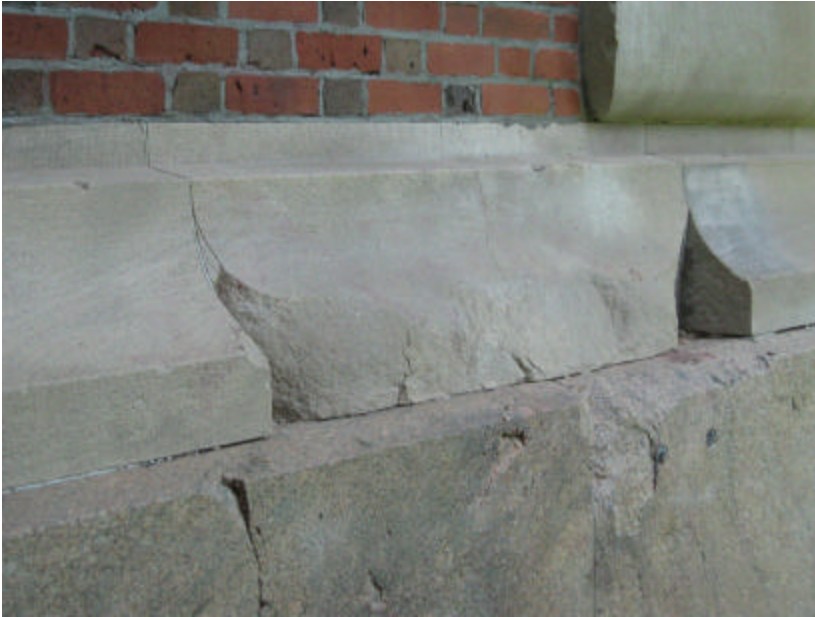
Photo 222
Severe spalling and cracking of the limestone and granite base on the north pavilion.

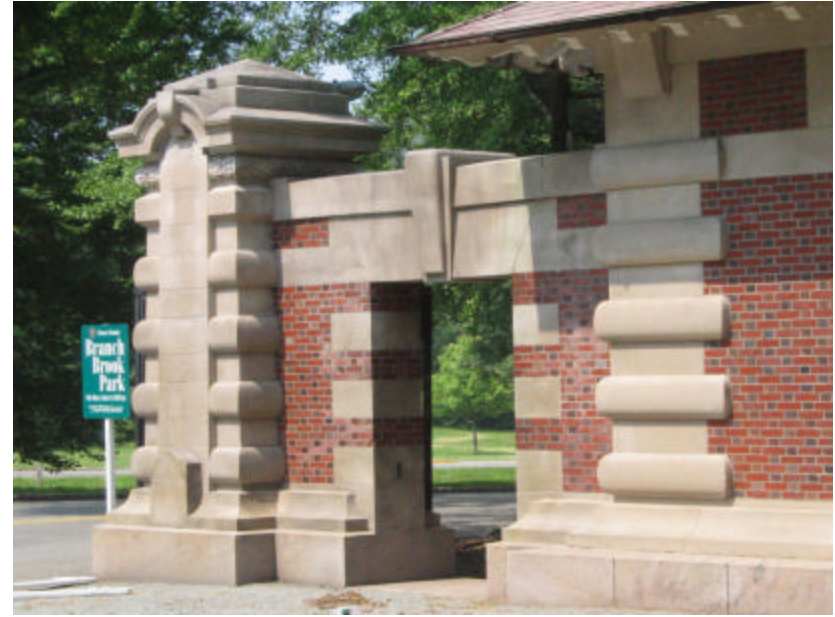
Photo 223
The pedestrian entrance and limestone pier of the north pavilion.

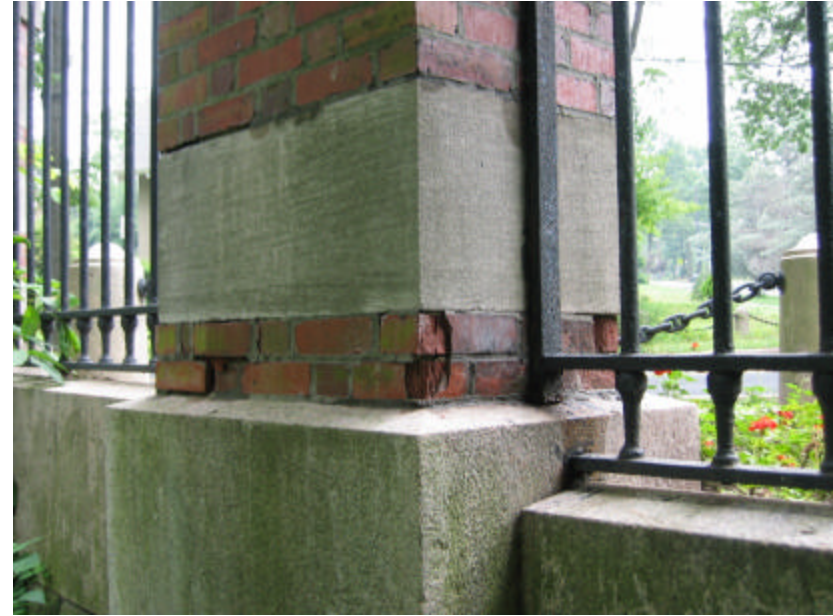
Photo 225
Spalled and cracked brick at the base of a post; note the poor condition of the bed joints between the limestone and brick.

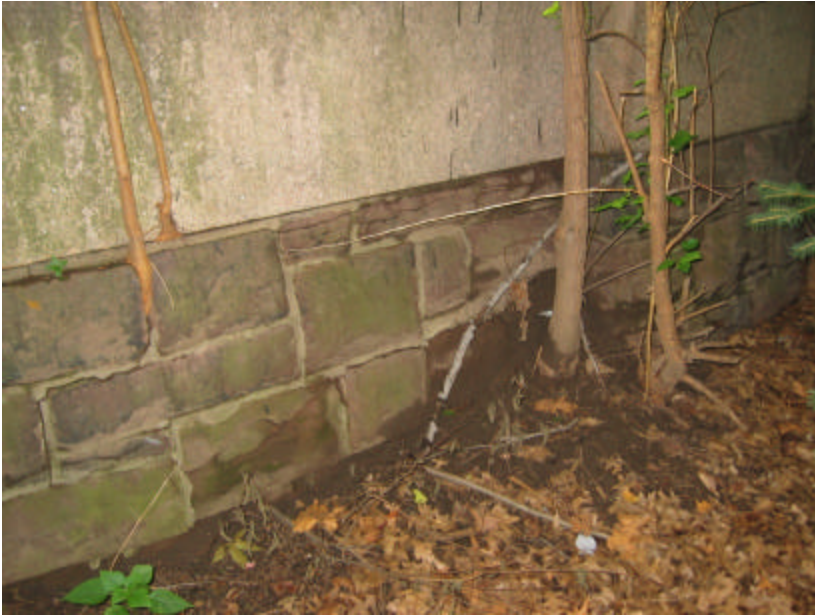
Photo 226
The brownstone retaining wall extending from the north pavilion; note that trees are growing out of cracks in the wall.

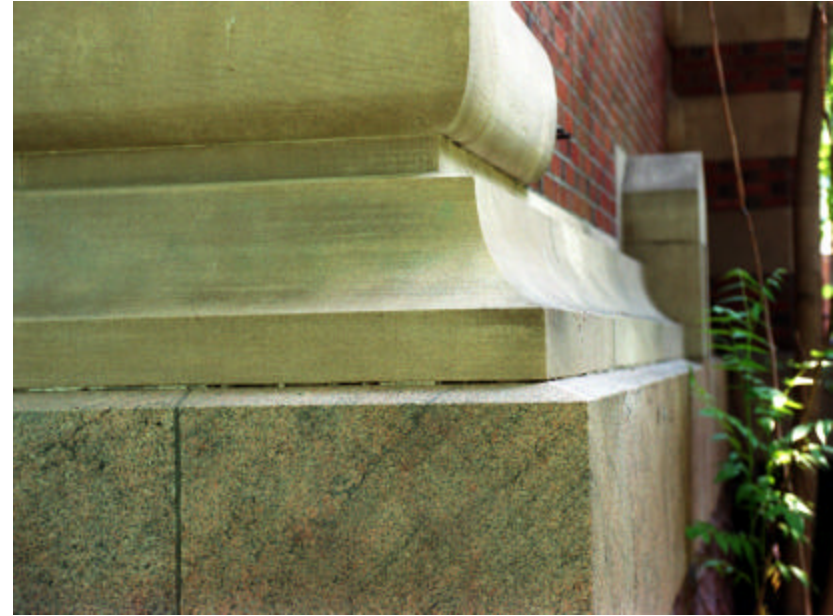
Photo 227
The southwest corner of the south pavilion; note the open and exposed vertical and bed joints.

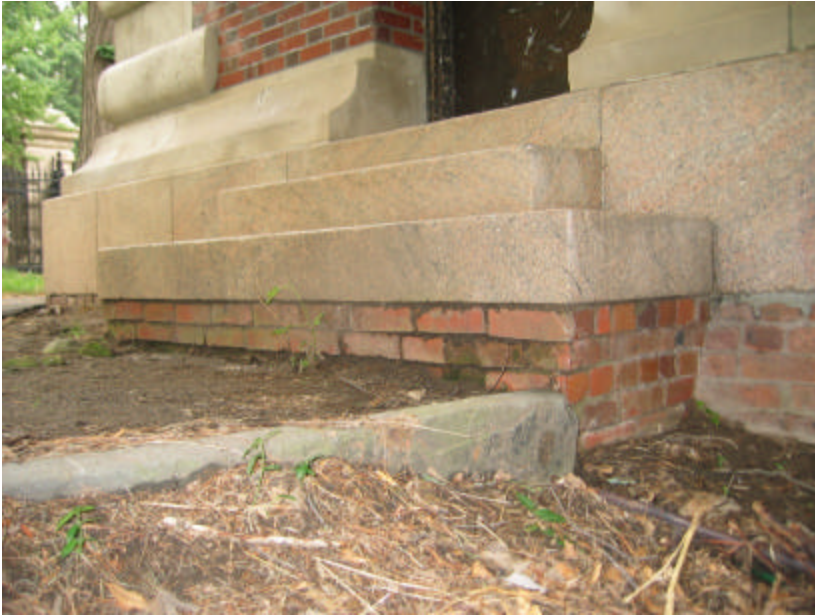
Photo 228
Corbelled brick foundation supporting the stoop; note the erosion around the site.

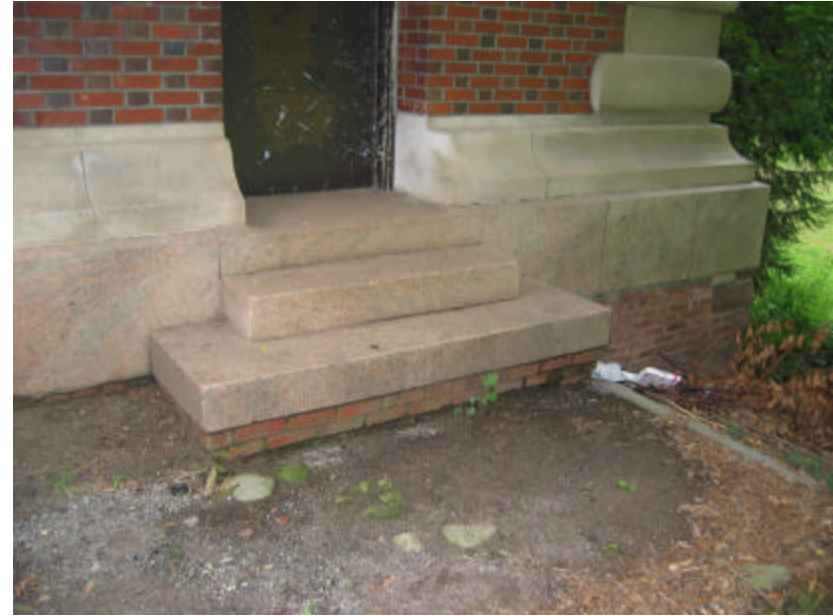
Photo 229
The stoop and doorway of the south pavilion; note the curb extending out from the stoop on the right side of the photo.

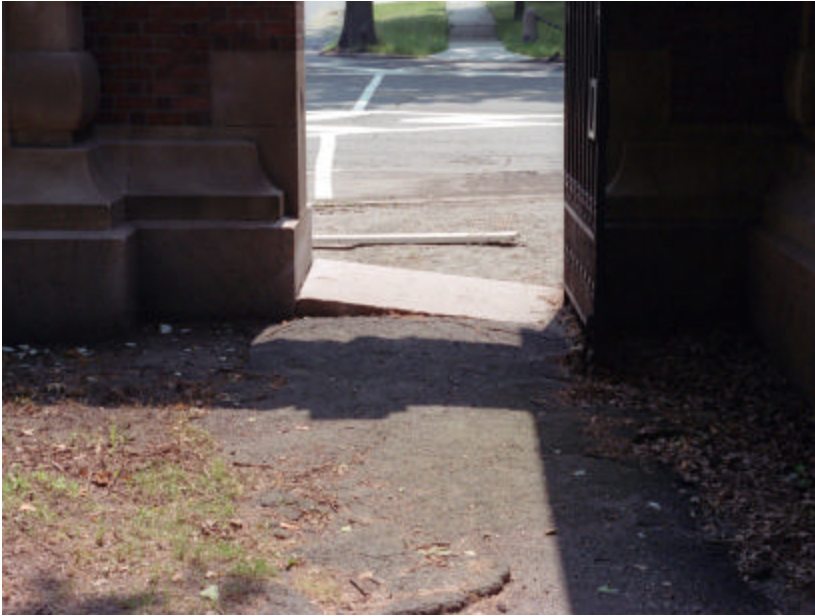
Photo 230
The displaced granite threshold; note the worn-out paving around the site.

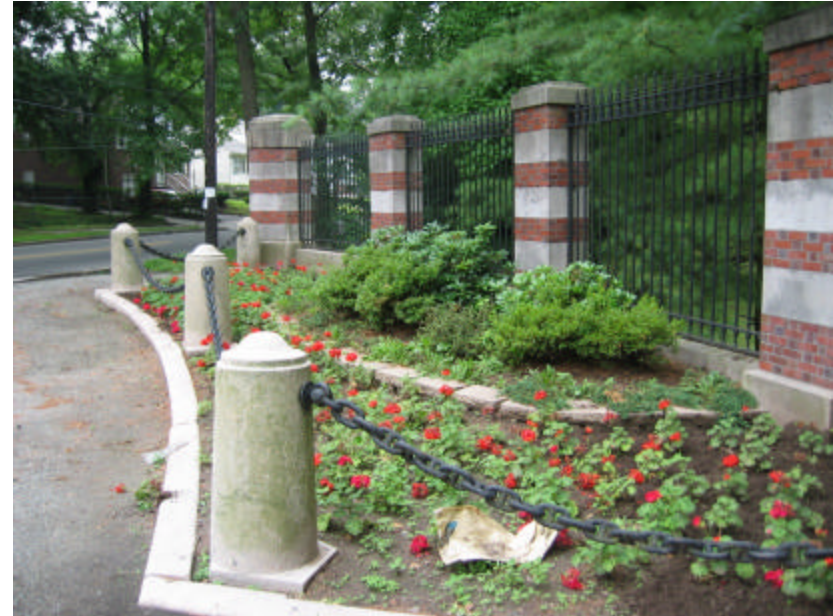
Photo 231
The fence, bollards and landscaping next to the south pavilion.

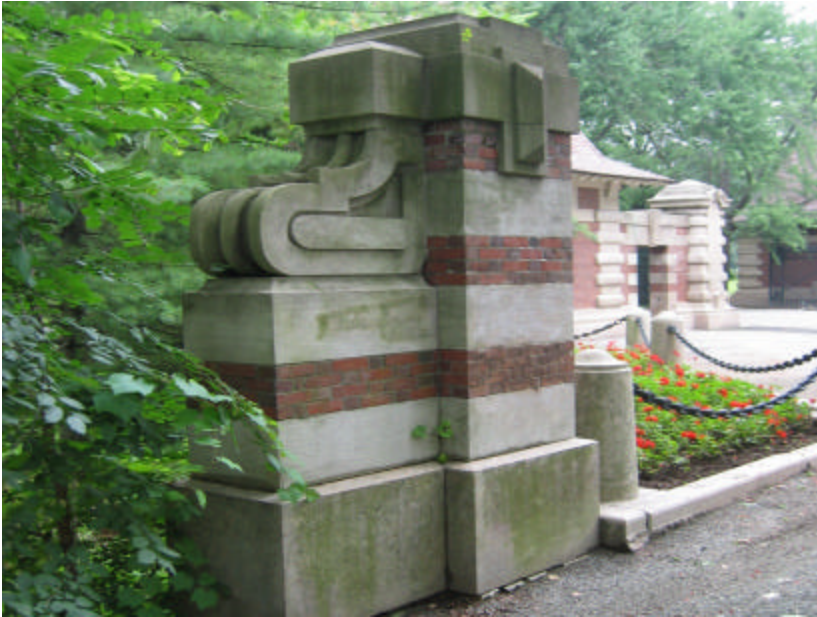
Photo 232
The post at the end of the south fence; note the eroded foundation.

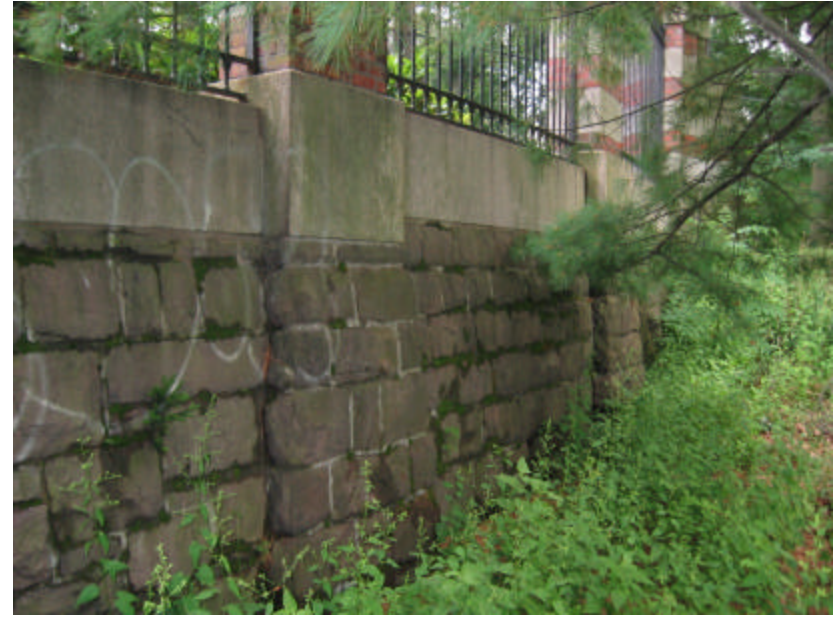
Photo 233
The brownstone retaining wall of the south pavilion; note the moss and graffiti covering the mortar joints and brownstone.

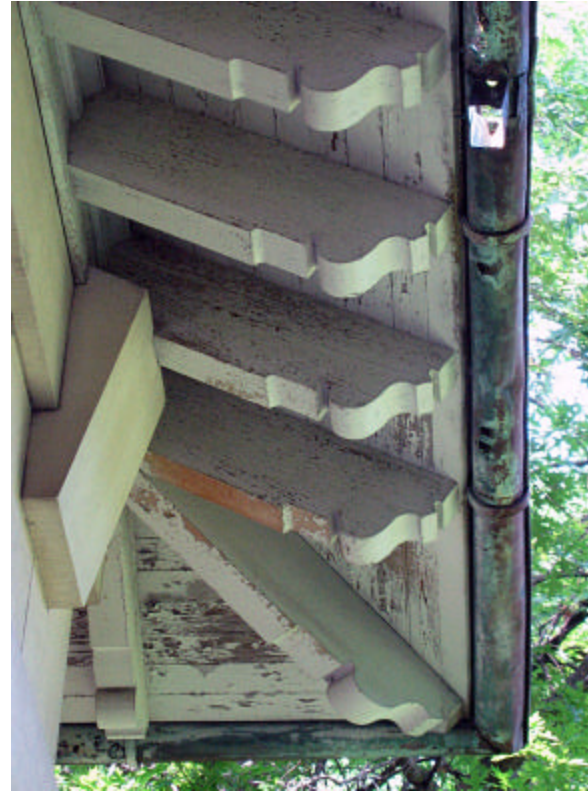
Photo 235
Carved ends of the wooden rafters and the beaded wood board sheathing; note the chipping and cracking of the paint on the rafters as well as the rotted wood sheathing. Also note the condition of the copper gutters and missing downspout.
