21. MIDWOOD POOL BRIDGE

INTRODUCTION

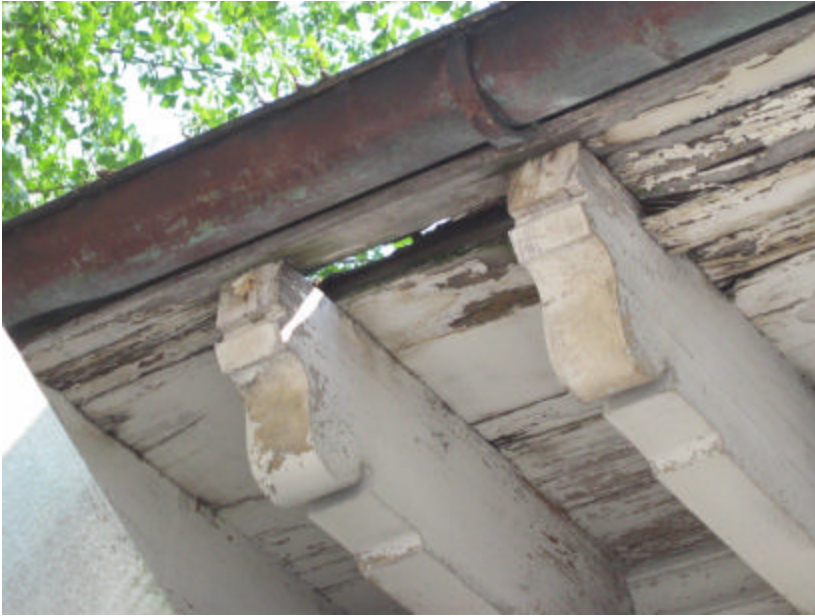
Photo 236
Severely rotted beaded wood board sheathing on the north pavilion.

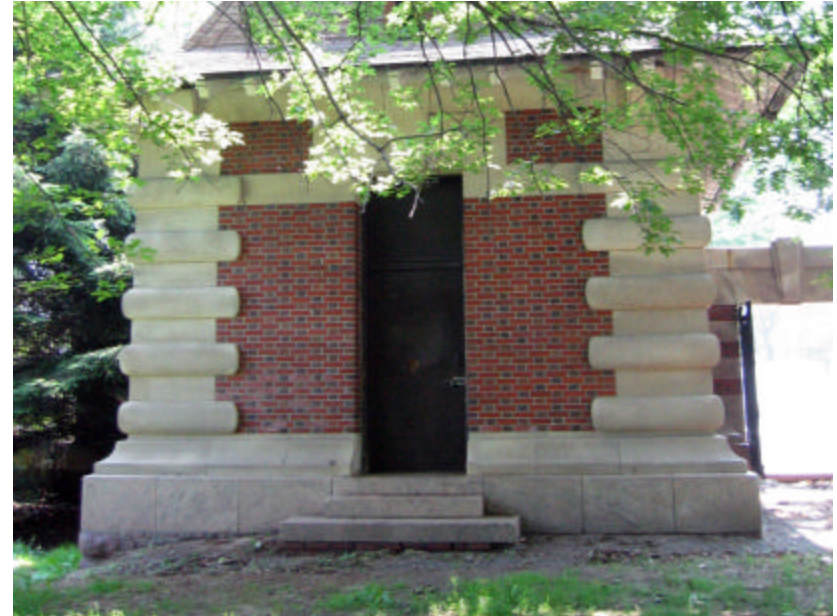
Photo 237
The west façade of the north pavilion; note the original door has been replaced with a sheet of plywood.

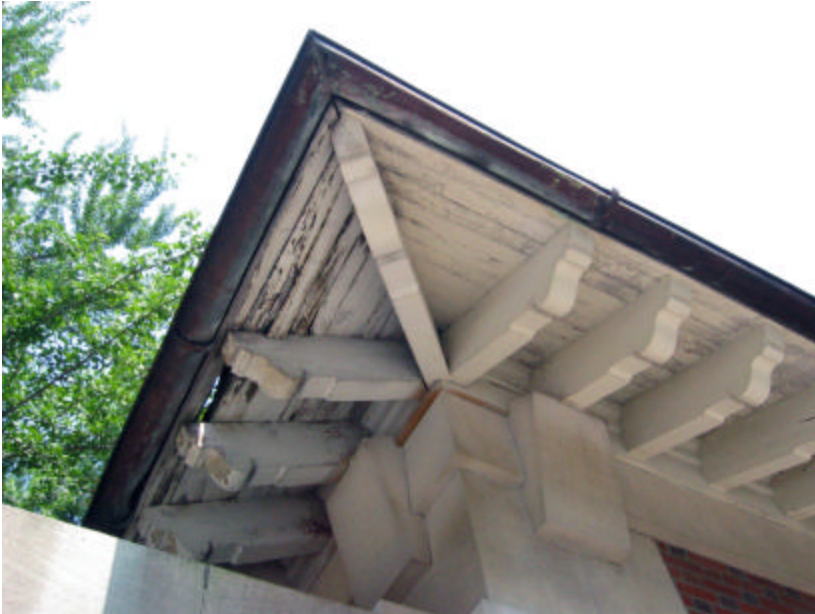
Photo 238
Copper gutters on the edges of each pavilion; note the poor condition of the eaves.

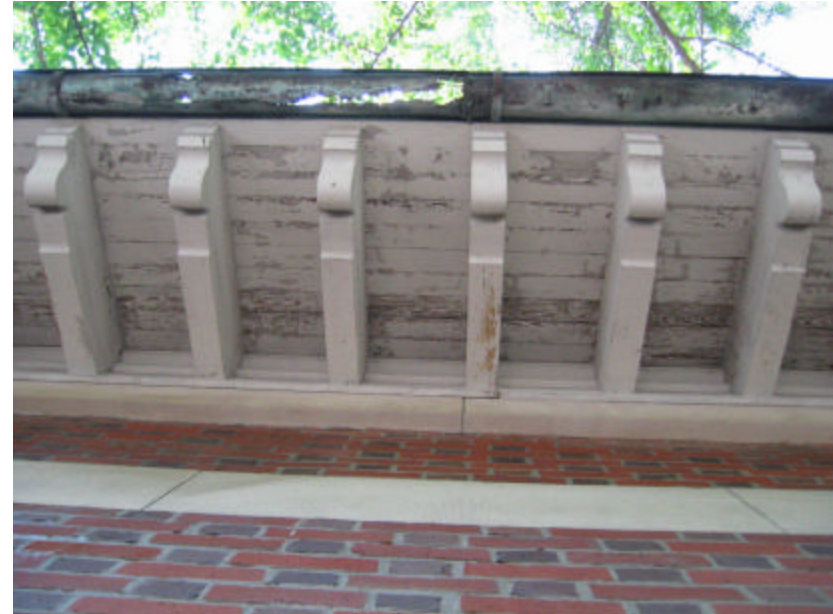
Photo 239
Completely corroded gutter on the north pavilion.

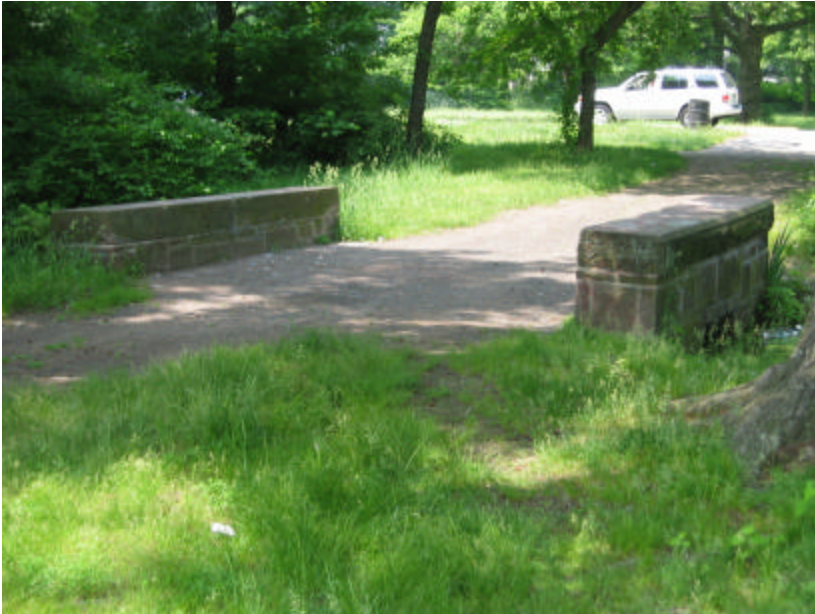
Photo 240
View looking west towards the crossover bridge.

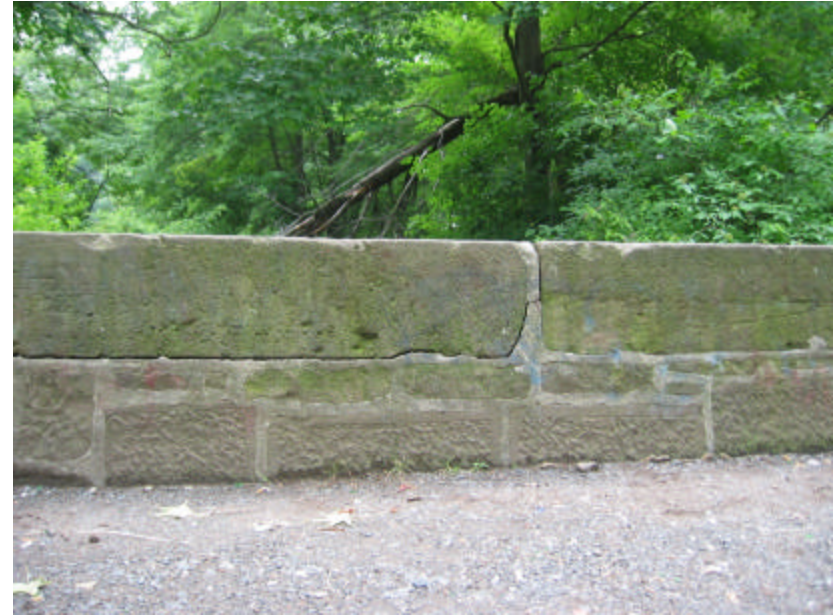
Photo 245
The cracked bed joint at the base of a copingstone on the south cheek wall.

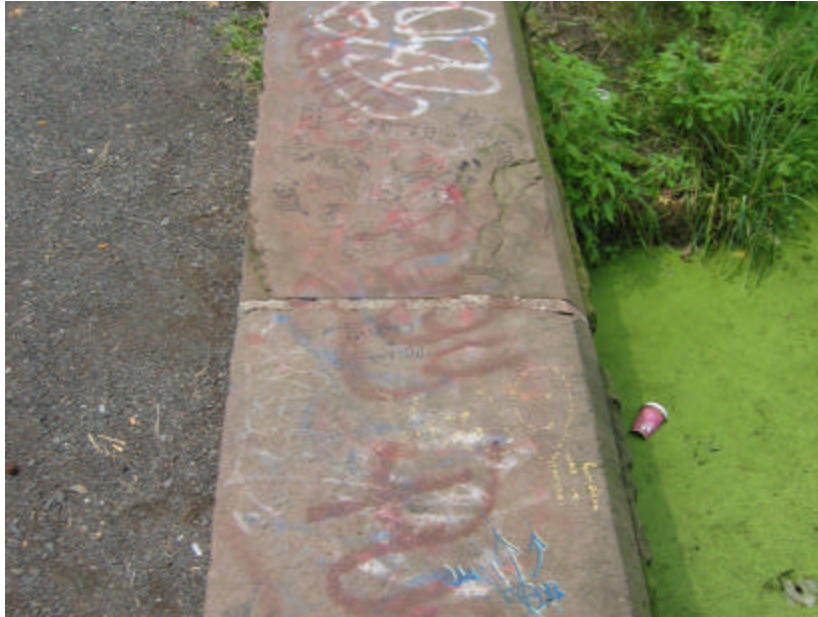
Photo 246
The copingstones atop the north cheek wall; note the spalling and delaminating stone as well as the graffiti.

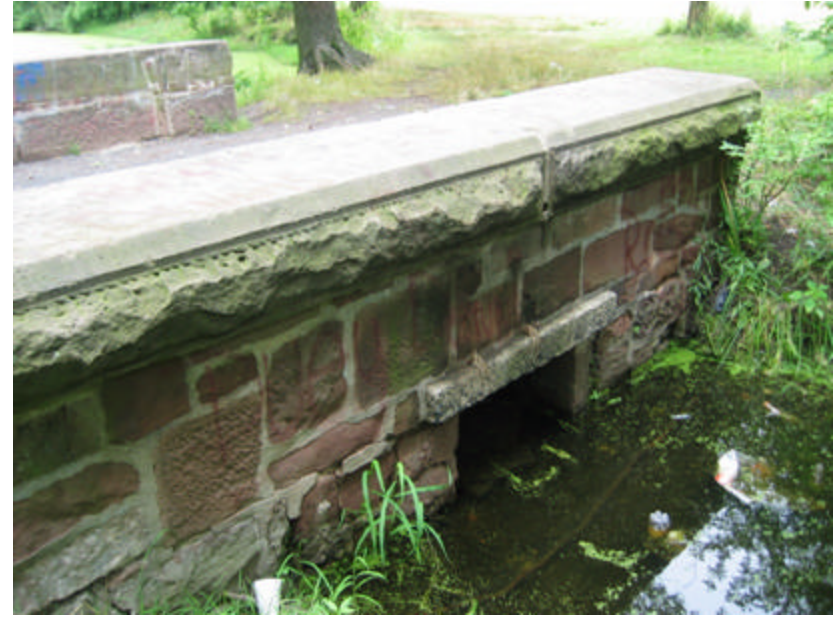
Photo 247
Missing and eroded mortar and brownstone at the base of the south cheek wall; note the dressed, beveled edges and rough-cut surfaces on the copingstones. Note also the limited water flow area of the channel opening.

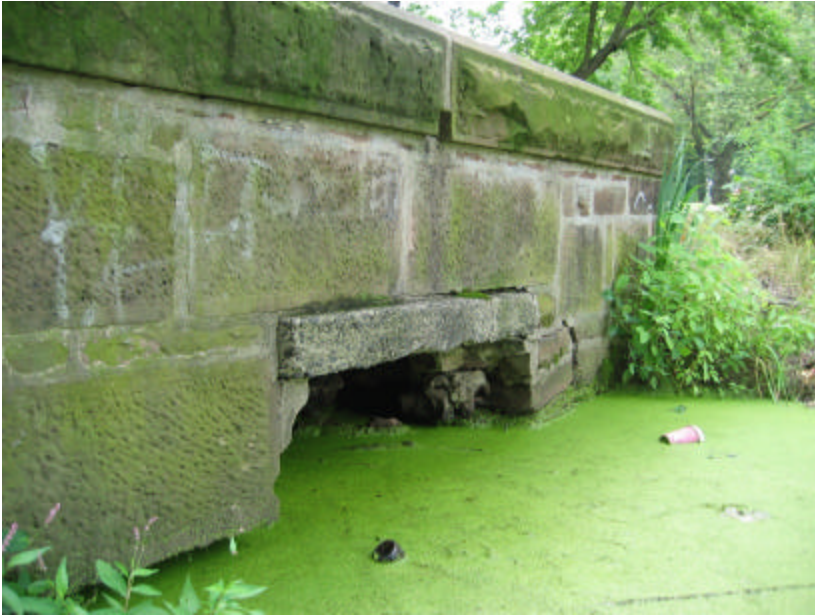
Photo 248
The concrete replacement lintel on the north side of the bridge; organic growth and graffiti; note the limited channel flow area.

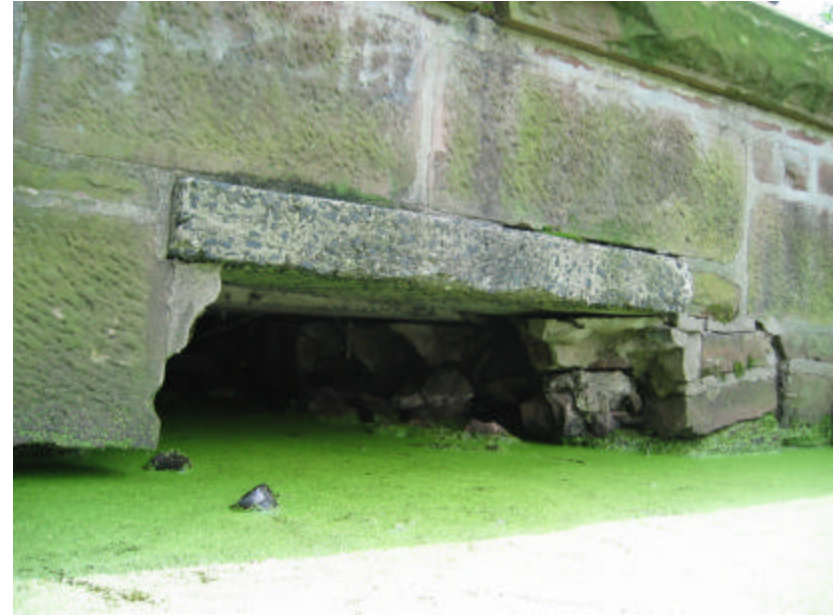
Photo 249
Cracked and missing brownstone and mortar on both sides of the bridge.

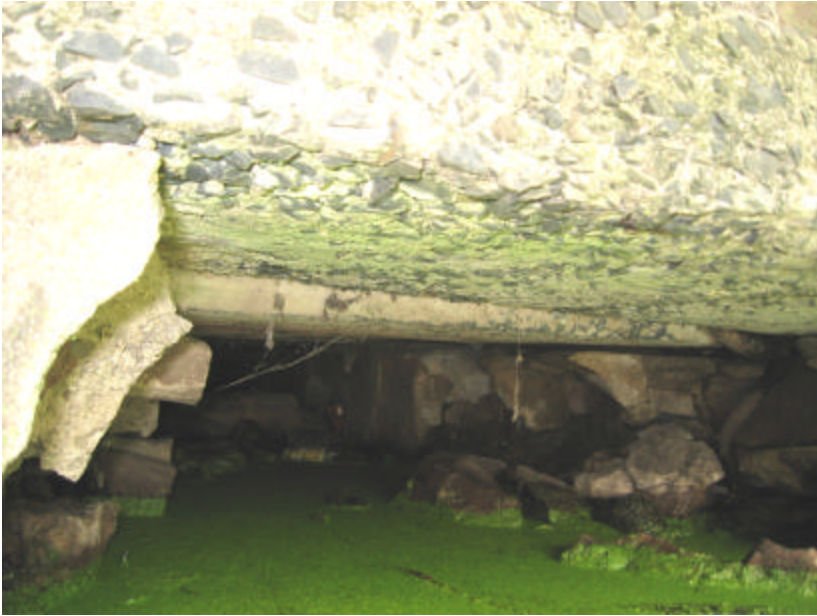
Photo 250
Displaced and broken pieces of concrete and brownstone under the bridge.

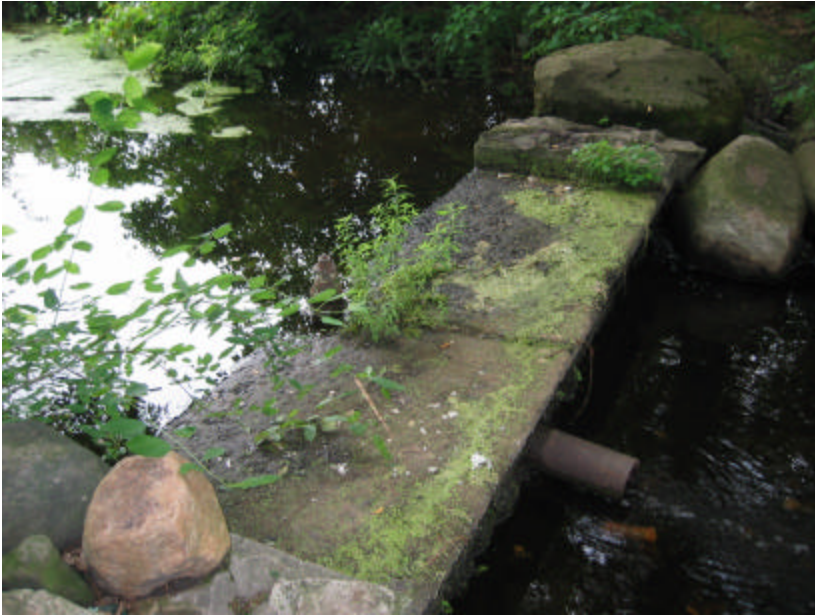
Photo 251
This weir is directly north of the brownstone bench bridge; note the pipe where water drains from the base of the weir.

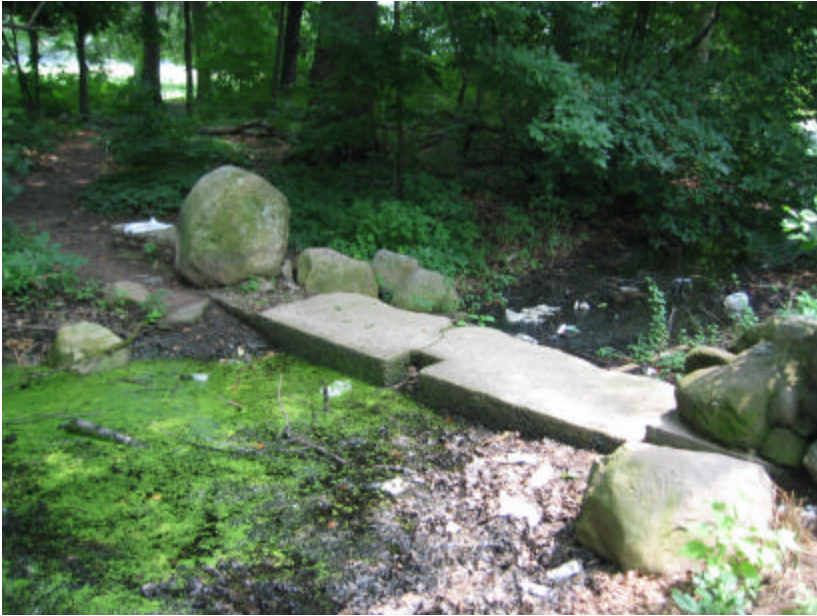
Photo 253
The fourth weir is constructed from concrete and also has a pipe that serves as a drain at its base.

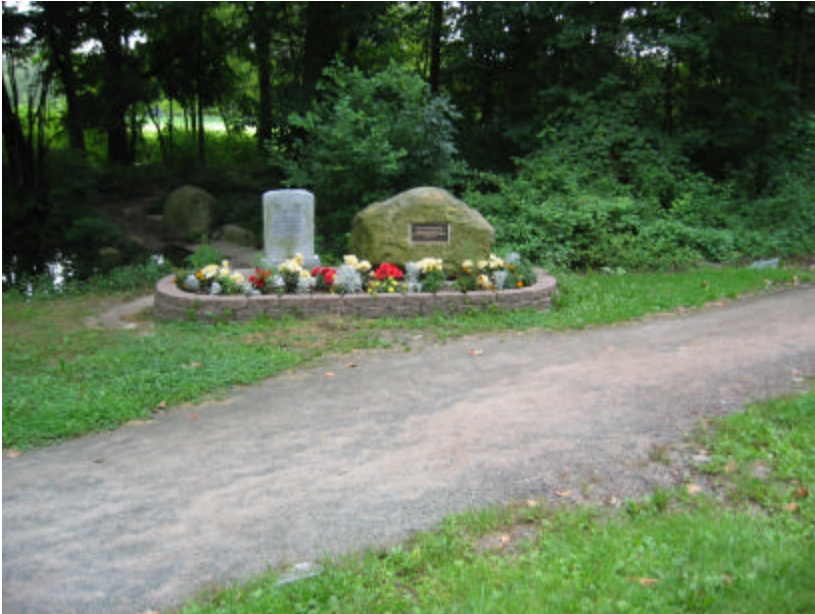
Photo 255
Policemen's Memorial, erected in memory of Police Office Dewey J. Sherpo III, located between the Park Drive and Weir 4 on the Branch Brook.

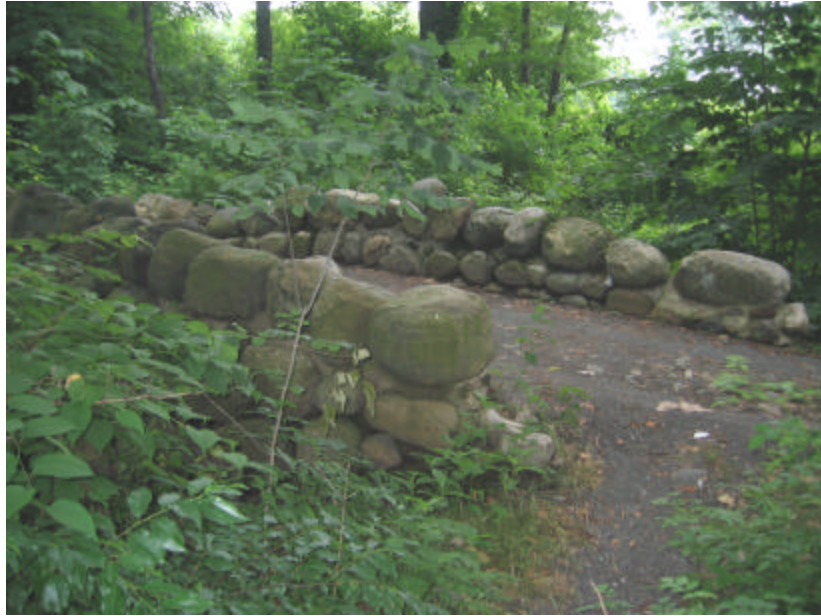
Photo 258
The Brookside Meadow Bridge; note overgrown vegetation around the site and the eroded dirt and gravel pathway.

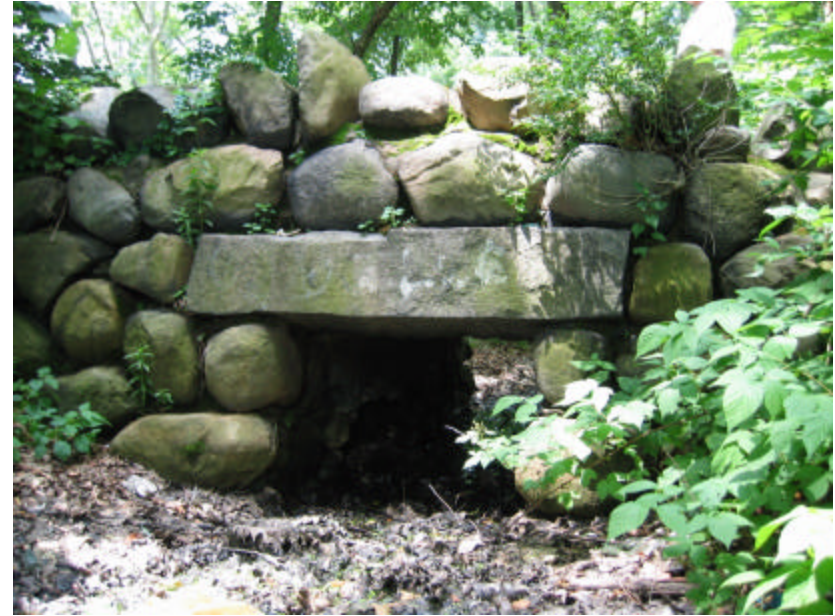
Photo 261
The rustic stonework on the west side of the bridge; note the bushes and trees overgrowing the bridge and site.

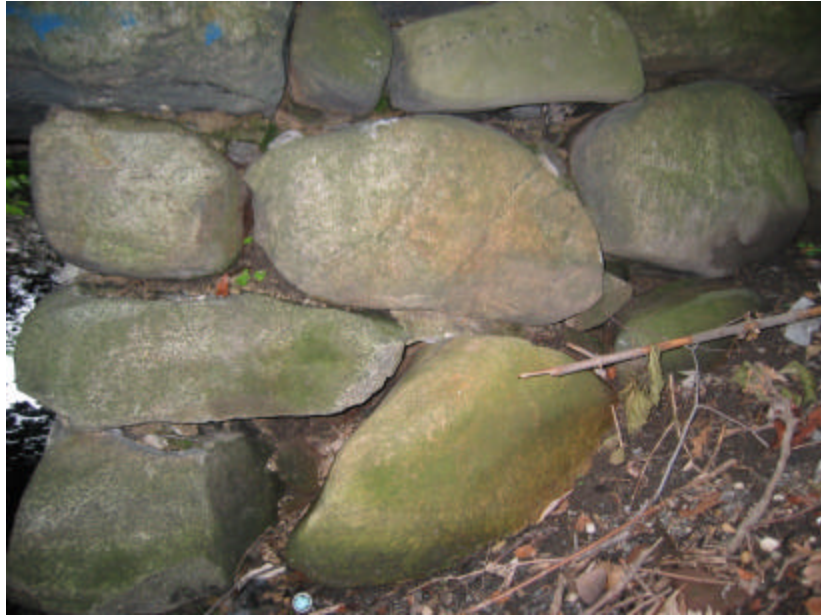
Photo 262
The mortar between these fieldstones on the base of the west cheek wall has eroded significantly or washed away completely.

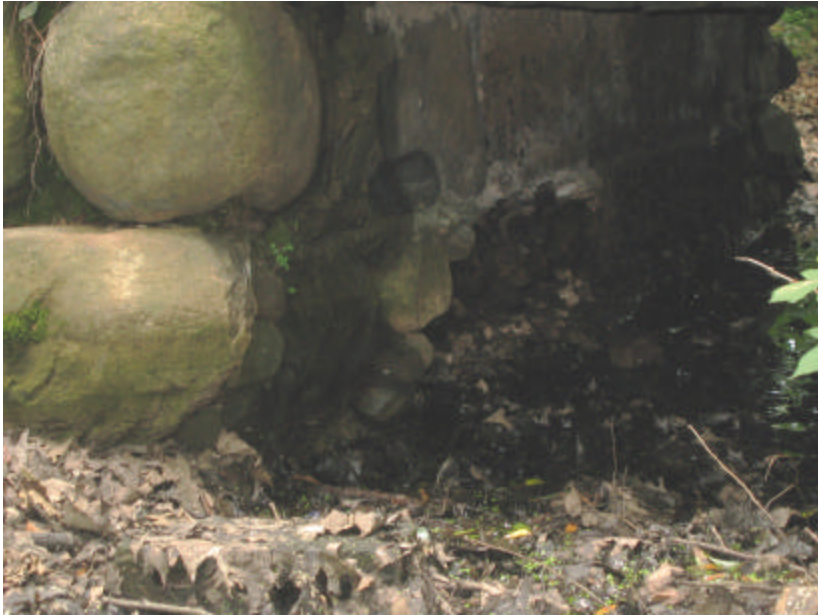
Photo 264
Significant spalling in the concrete box culvert underneath the bridge;
note the efflorescence and organic growth.

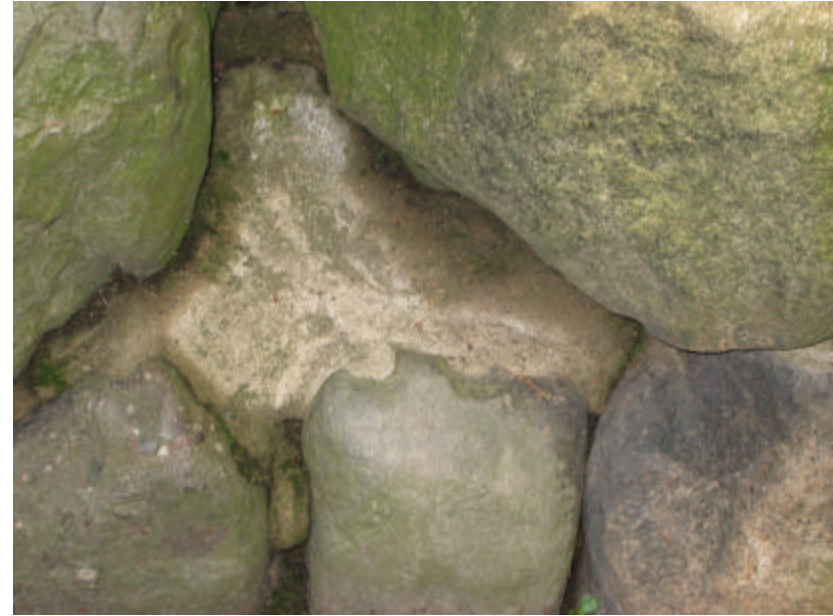
Photo 265
Mortar has been slathered on top of the west fieldstone cheek wall.

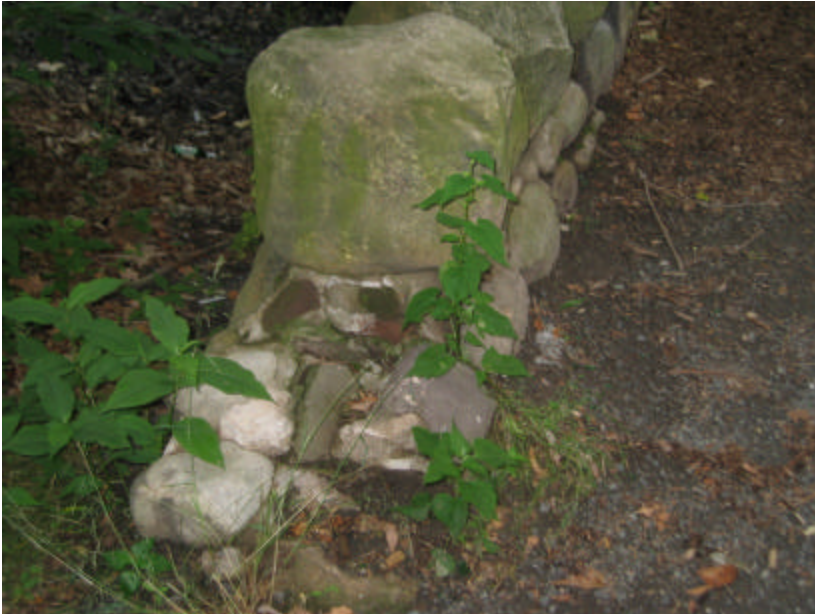
Photo 266
Fieldstones missing from the south side of the west cheek wall.

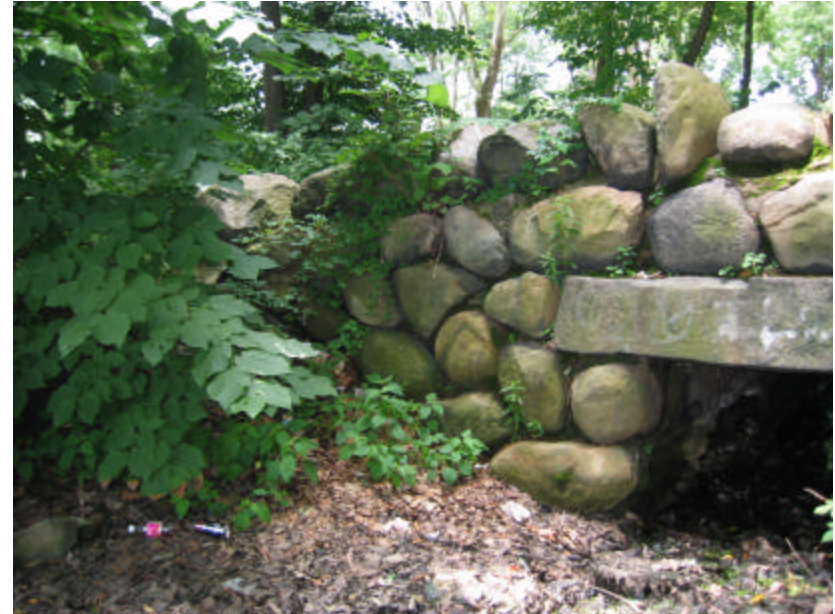
Photo 267
Bushes and plants growing from cracks on the south side of the east cheek wall; note the deeply eroded mortar joints.

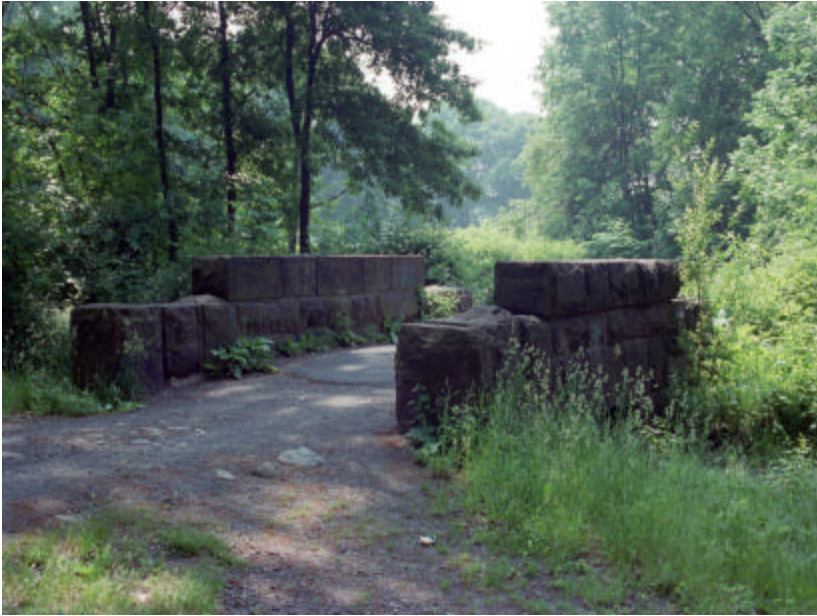
Photo 268
View southeast towards the brownstone lintel bridge; note the poor condition of the path.

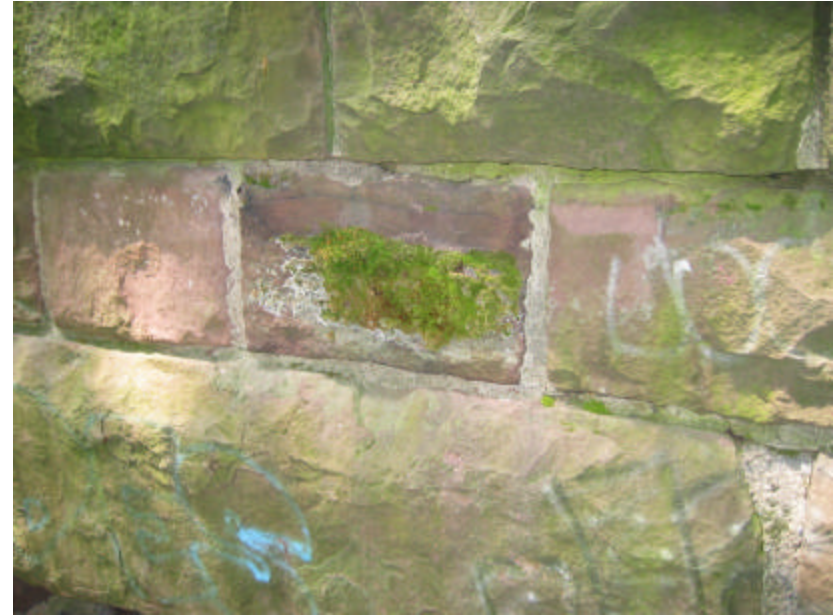
Photo 269
Organic growth and graffiti on the vertical face of the east cheek wall; note the large lintel stone on the bottom of the photo.

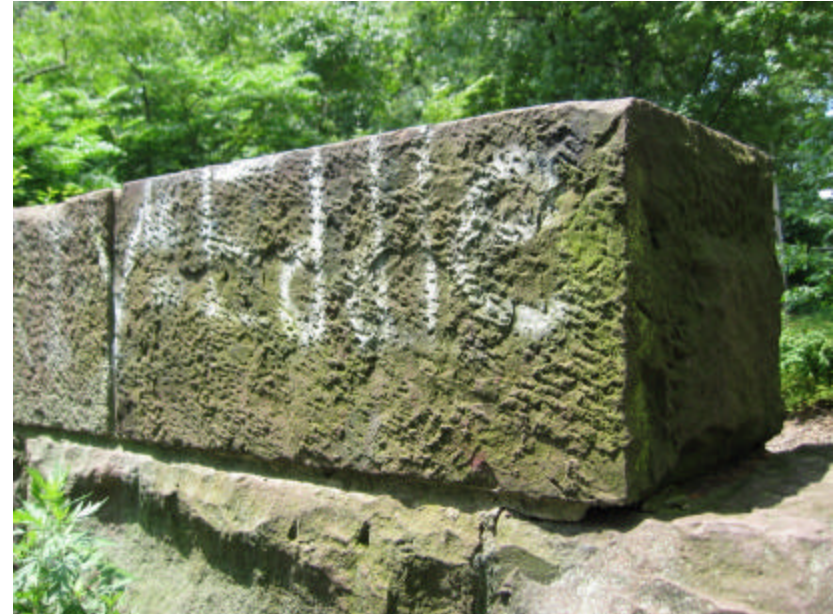
Photo 271
A detail of the brownstone atop the west cheek wall; note that the well-tooled stone surface is spalling and graffiti-covered.

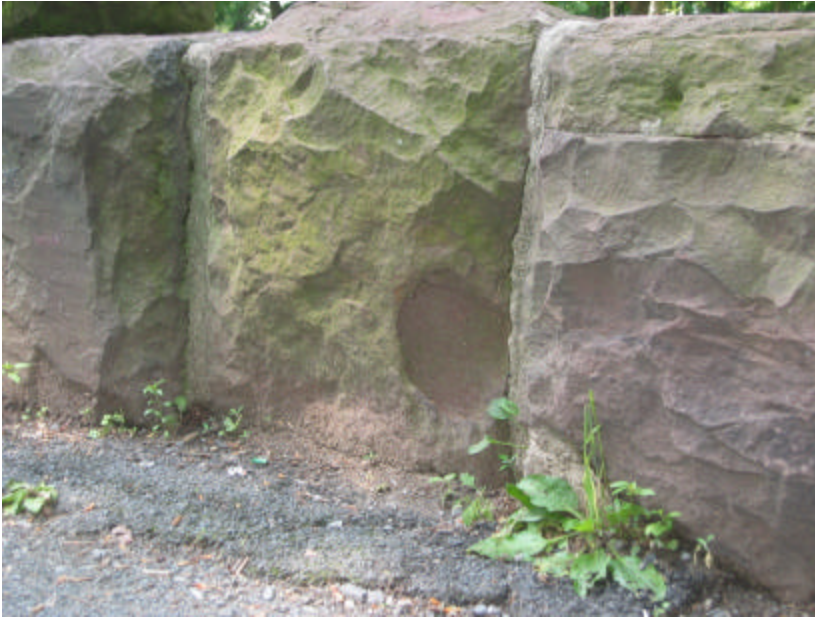
Photo 272
An area of circular spalling on the middle block; note that the top fifth of the block on the right has been reattached or replaced with new brownstone.

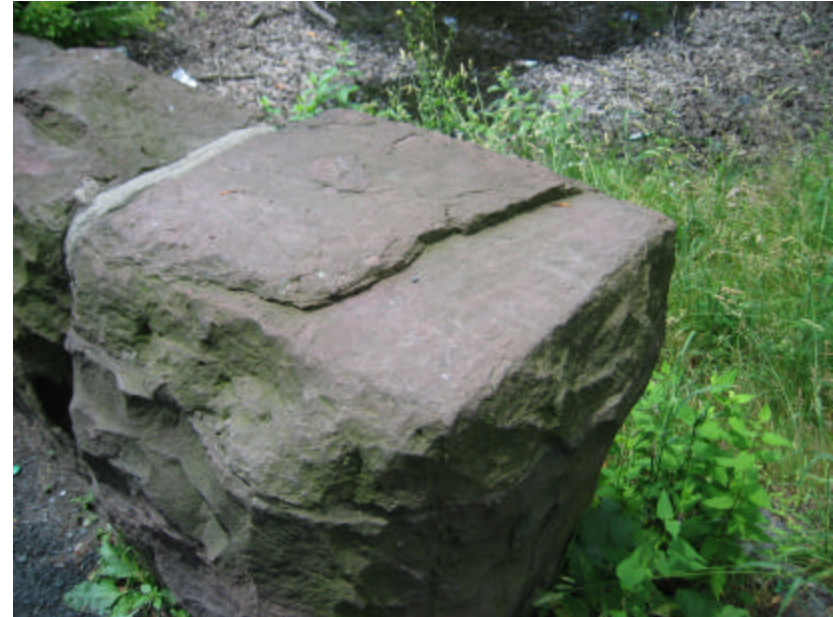
Photo 273
An end block of the west cheek wall; note that the top of this stone has delaminated and the joints have been repointed.

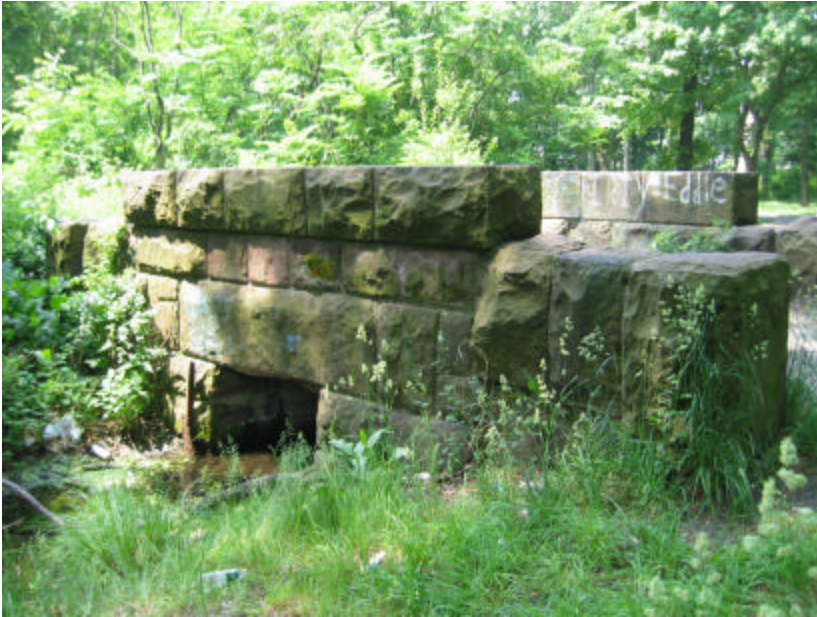
Photo 276
The coursed-ashlar and rough-cut brownstone, east cheek wall; note the green organic growth and spalling stone surface.

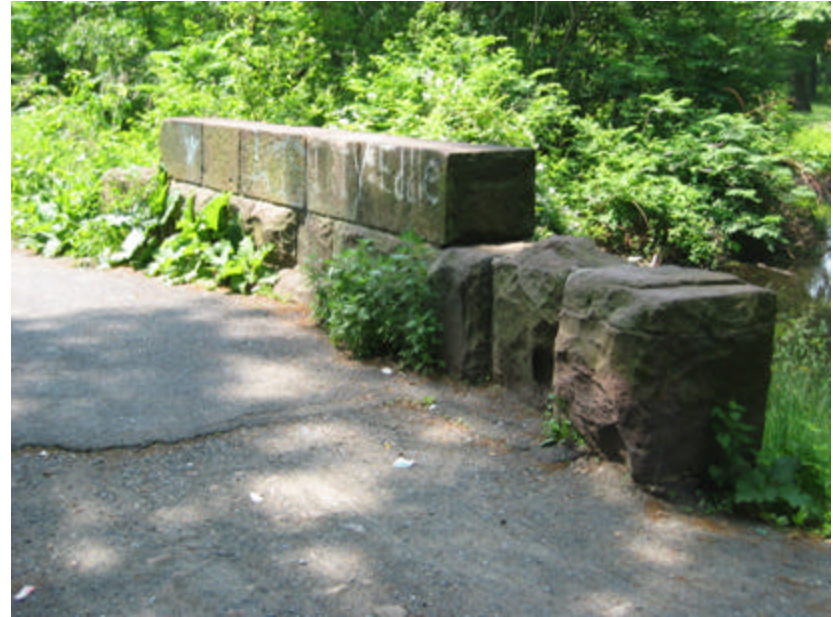
Photo 277
The west cheek wall; note the plant growth at its base and asphalt paving only on the bridge deck.

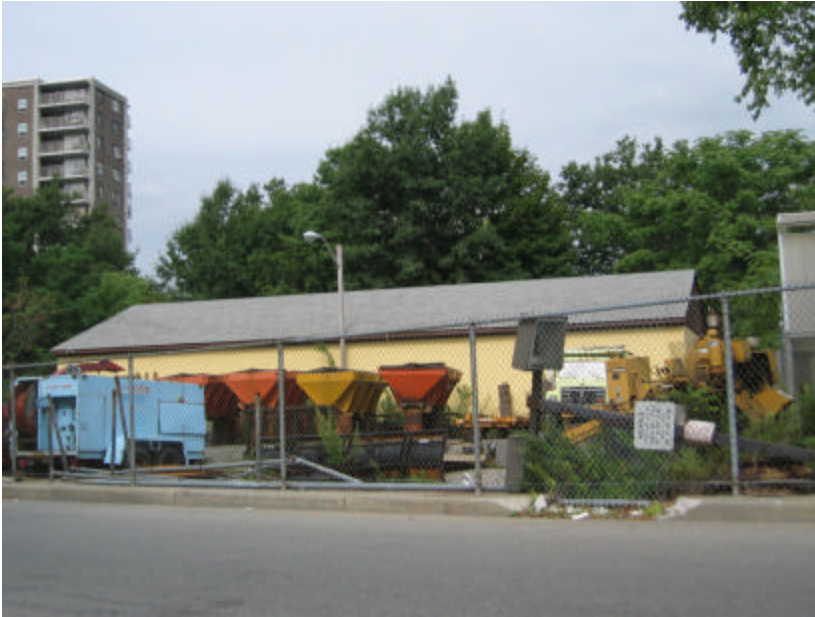
Photo 278
View of the Maintenance Facility site showing chain link fence along Park Drive and the badly damaged concrete curb; note the extensive array of material and equipment visible from the Park.

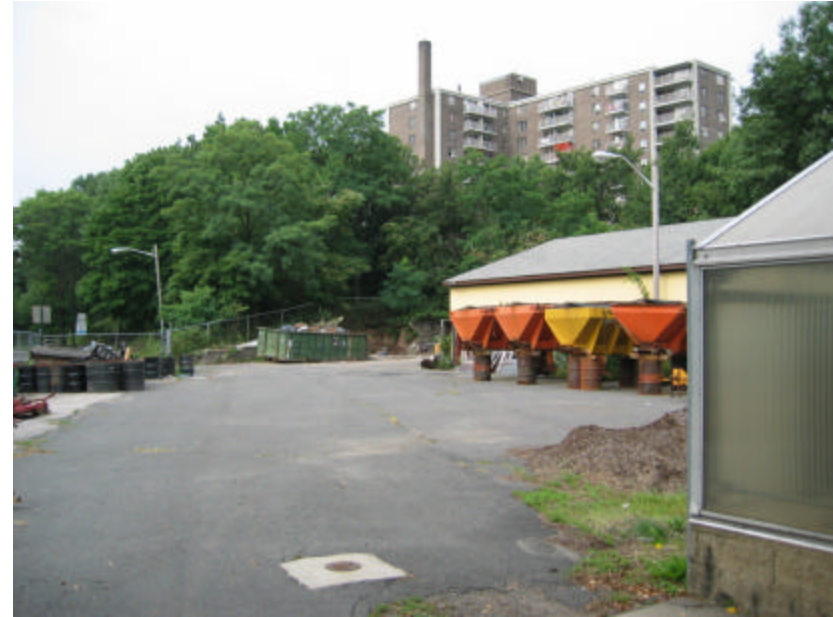
Photo 279
View of the Maintenance Facility, with the Storage Building beyond; note the southern site fence rising into the trees.

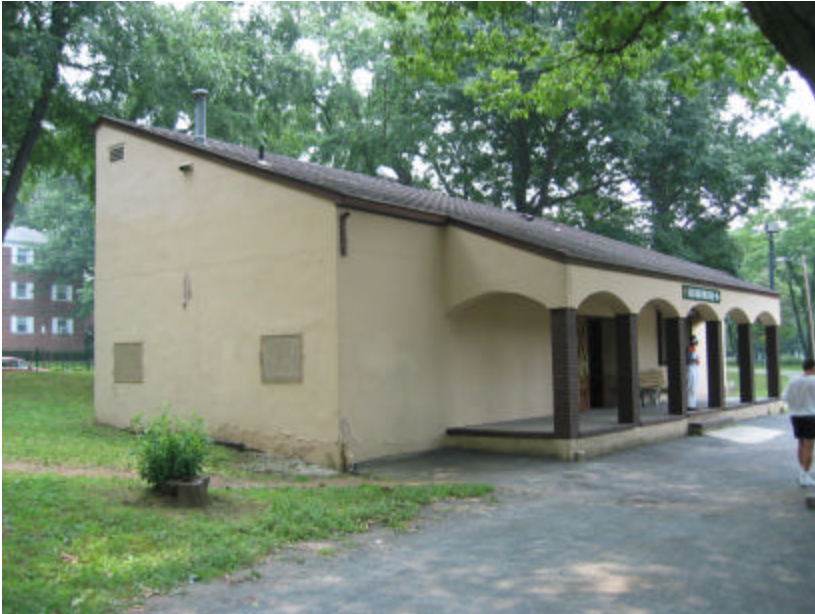
Photo 285
Overall view of the tennis center; note the arched porch.

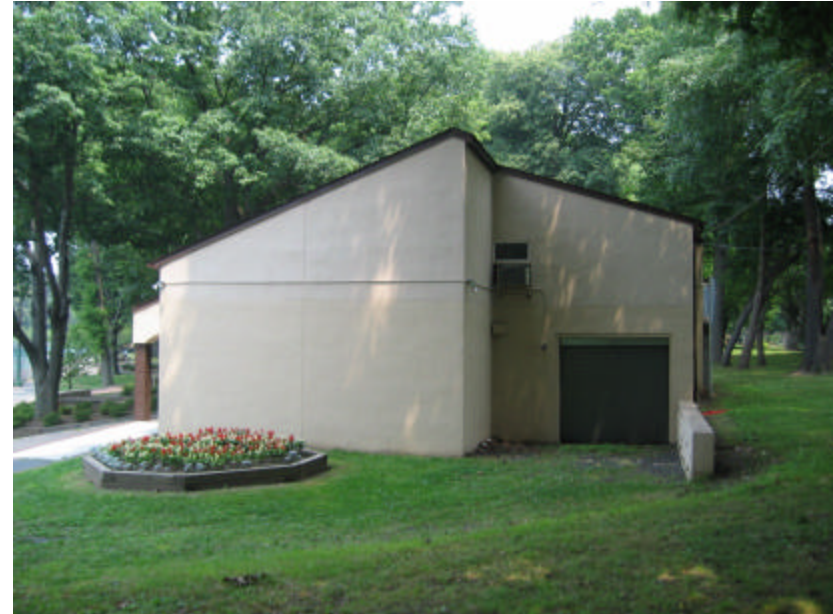
Photo 286
The small fixed window above the in-wall air conditioning unit; note the raised flower bed south of the building.

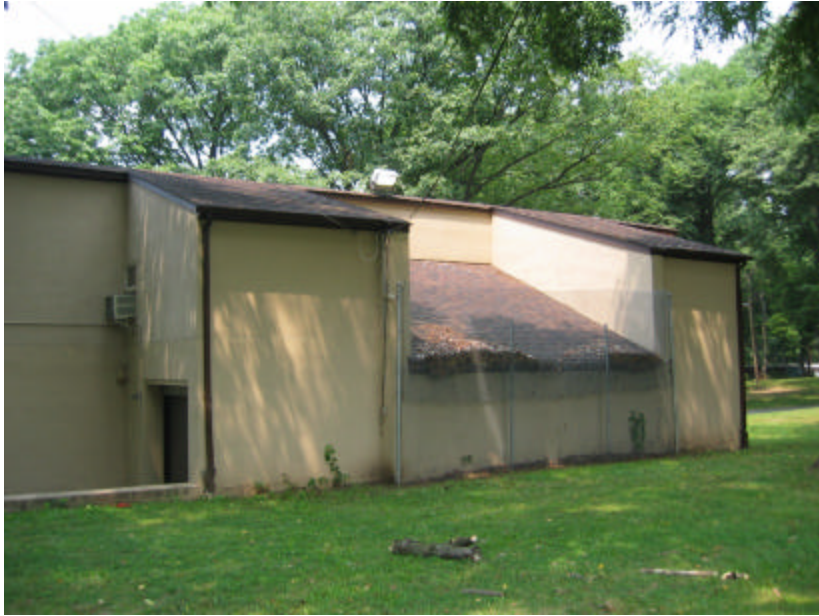
Photo 287
The sloped roof on the east side of the building; note that a fence has been placed there to prevent injury/vandalism.

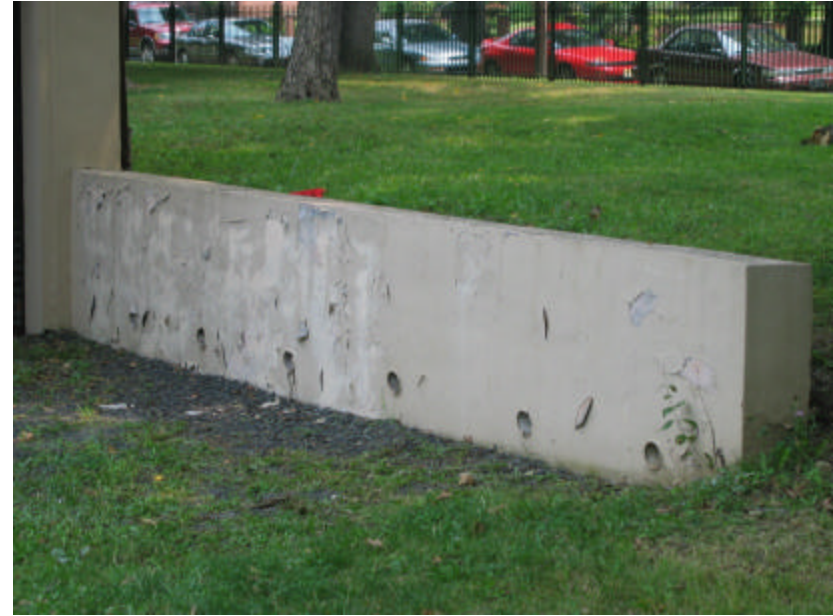
Photo 288
The concrete retaining wall has been damaged by water penetrating from the surrounding grade and freeze-thaw cycles; note the cracked and peeling paint.

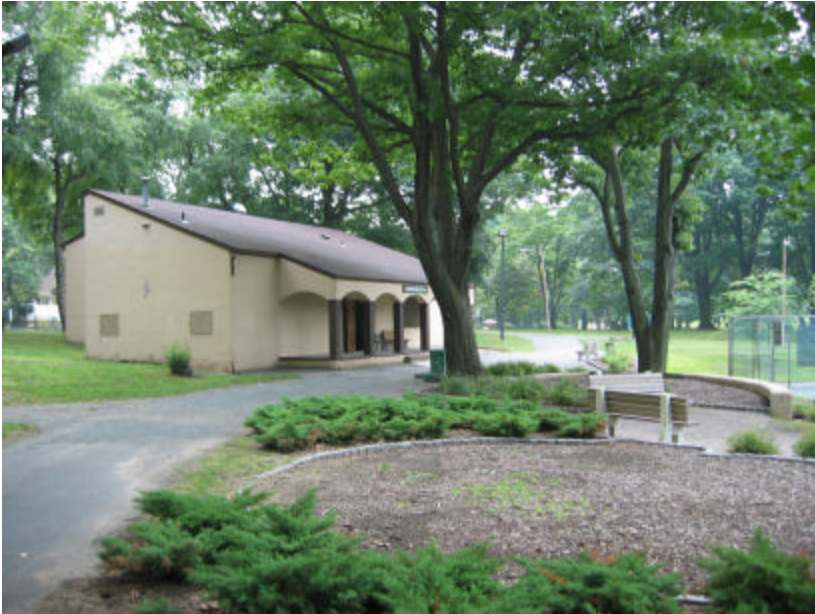
Photo 289
View of the tennis center from the north; note the areas of landscaping.

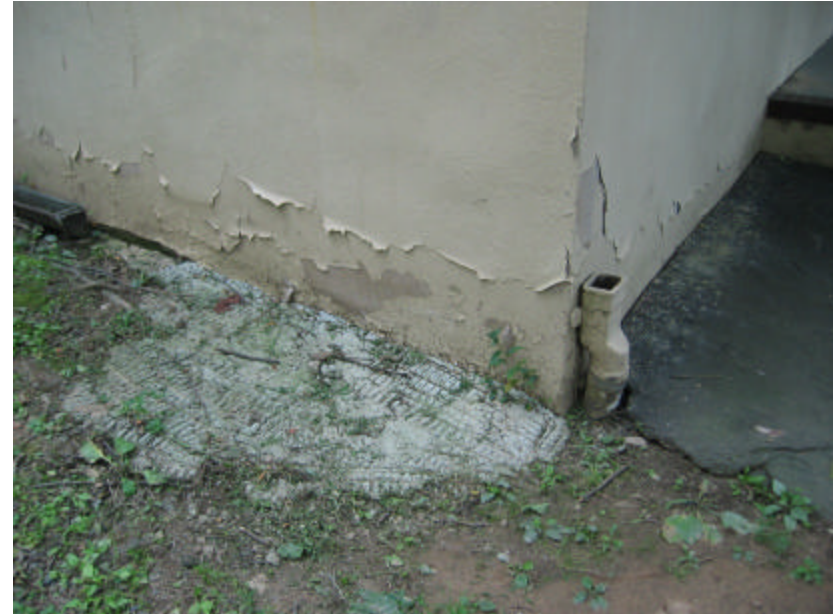
Photo 290
The base of the north wall showing cracked and peeling paint caused by water damage from a missing downspout; note the leftover concrete on the ground.

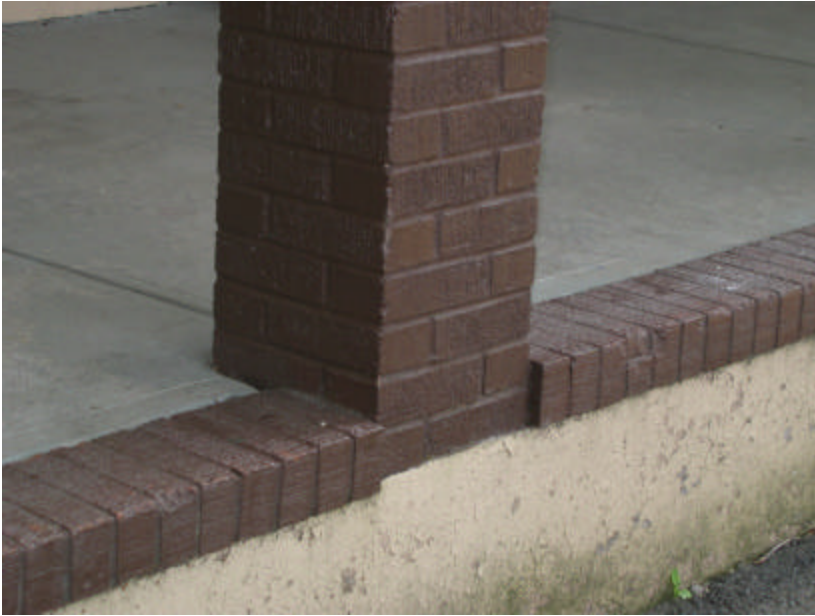
Photo 291
A square brick column and brick trim on the porch; note that the brick is covered with a heavy coat of brown paint.

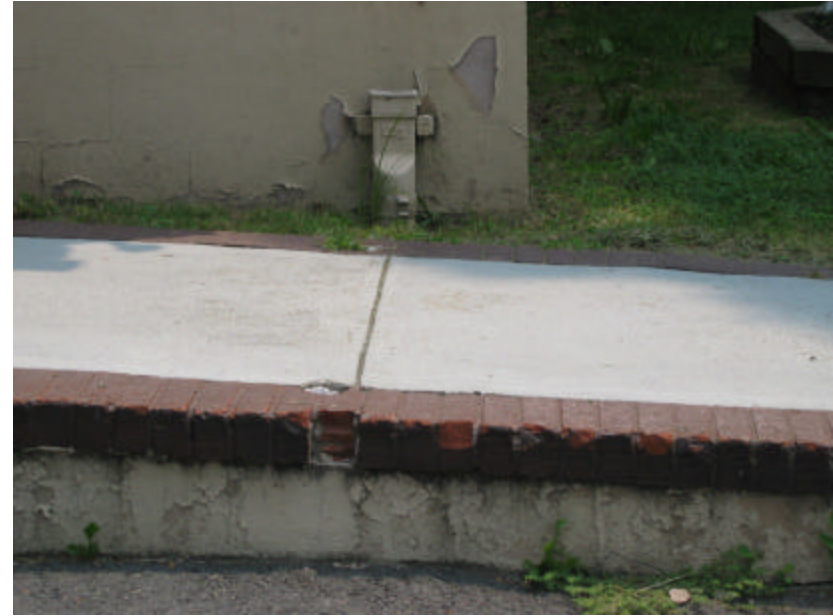
Photo 292
Cracked and chipped brick on the ramp leading to the porch; note the concrete below the brick is stained and soiled.

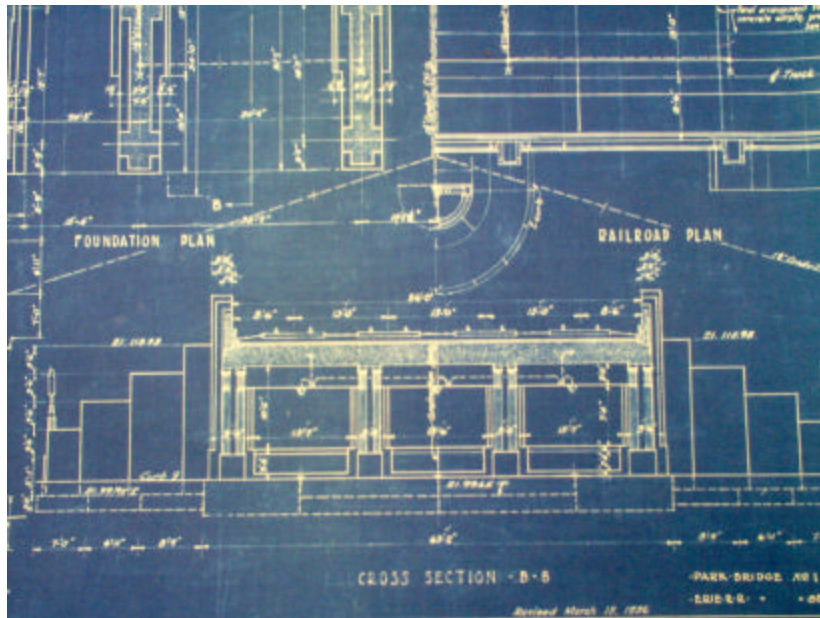
Original Drawing 25
This blueprint from an original drawing illustrates the bridge in section.

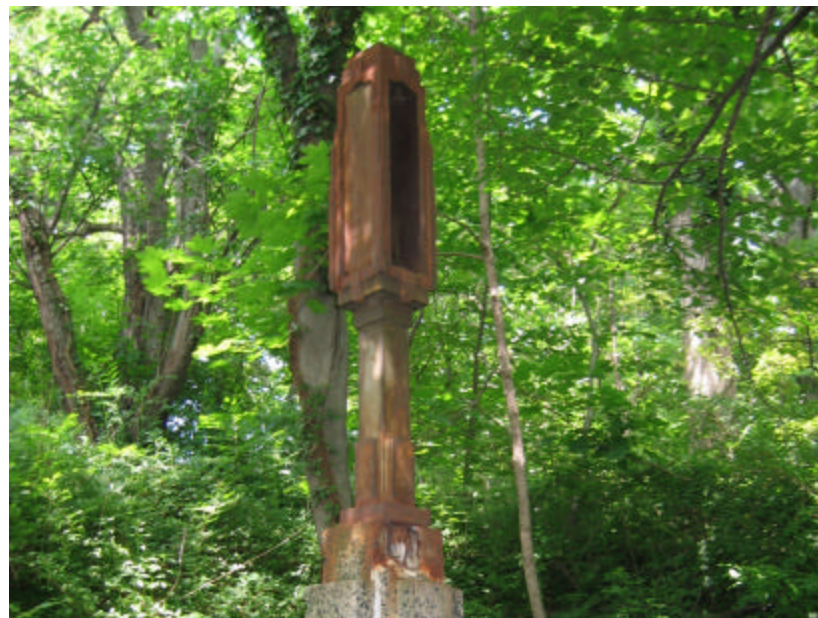
Photo 297
An original metal lantern atop a concrete base; note that the surface is severely rusted.

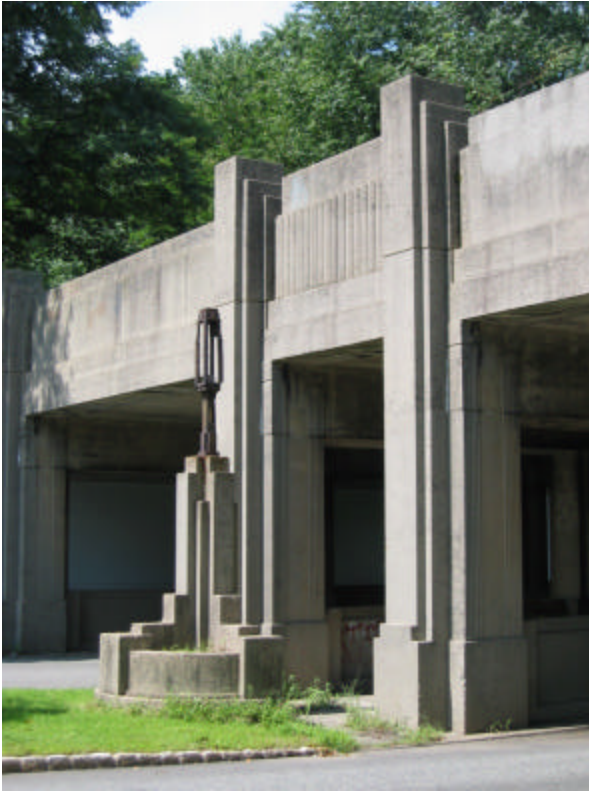
Photo 298
The south side of the bridge where the original streamline details of are clearly evident; note the effect of the vertical lantern and columns on the horizontal structure of the bridge.

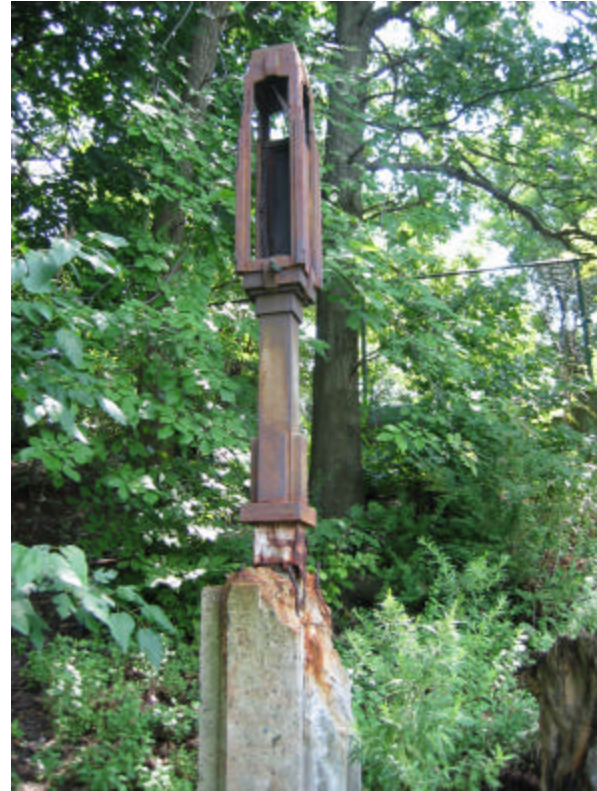
Photo 301
This lantern is covered with rust, and the concrete base has severely deteriorated; note the exposed and rusting steel reinforcing.

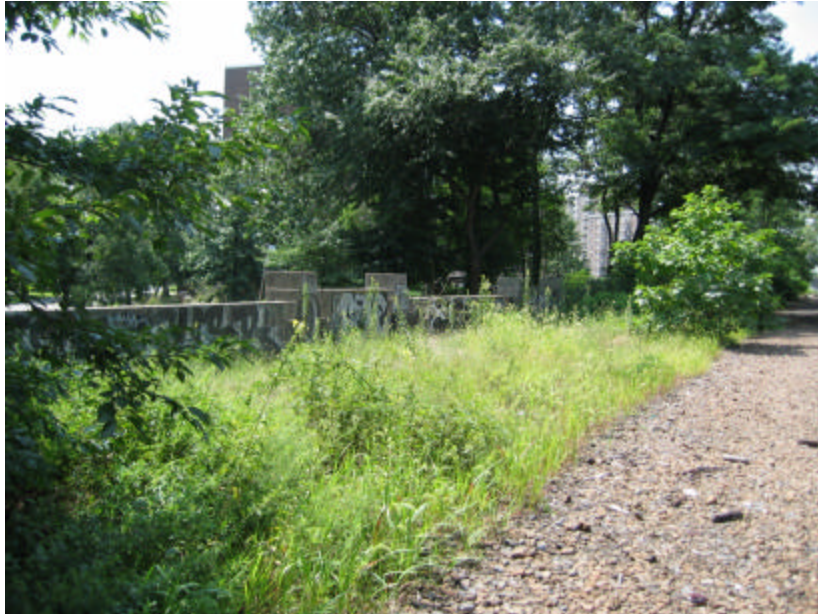
Photo 302
The south parapet wall on the top of the bridge; note that the wall is covered with graffiti and the site is overgrown with weeds.
