21. MIDWOOD POOL BRIDGE

INTRODUCTION

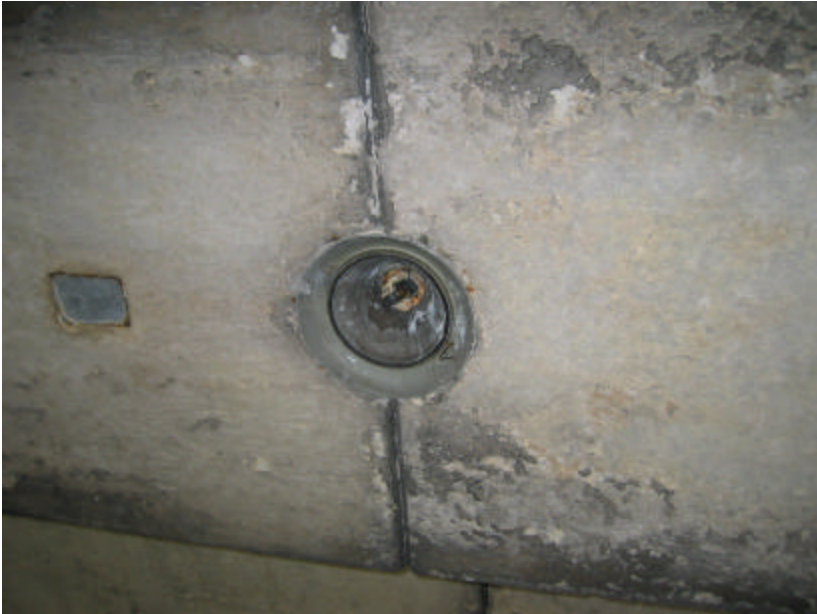
Photo 304
One of the broken recessed lighting fixtures on the underside of the bridge.

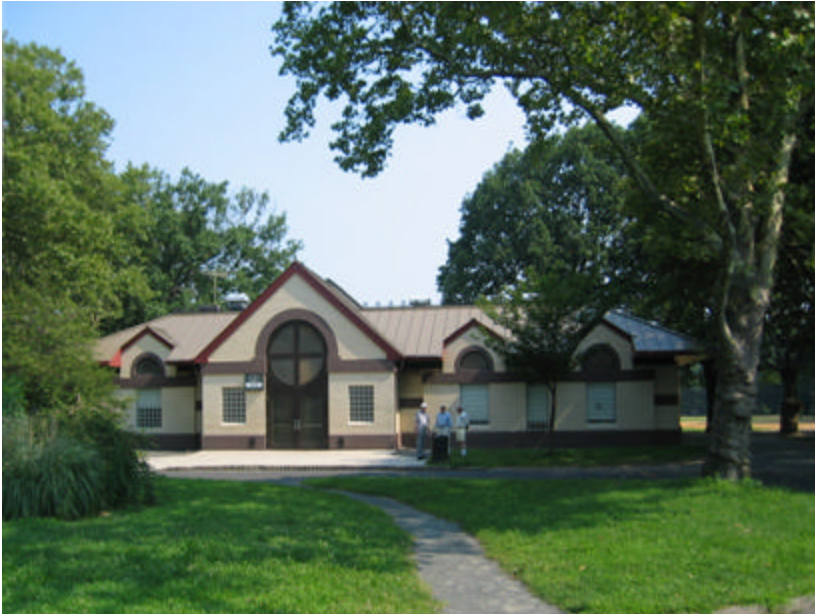
Photo 305
Overall view of the front façade.

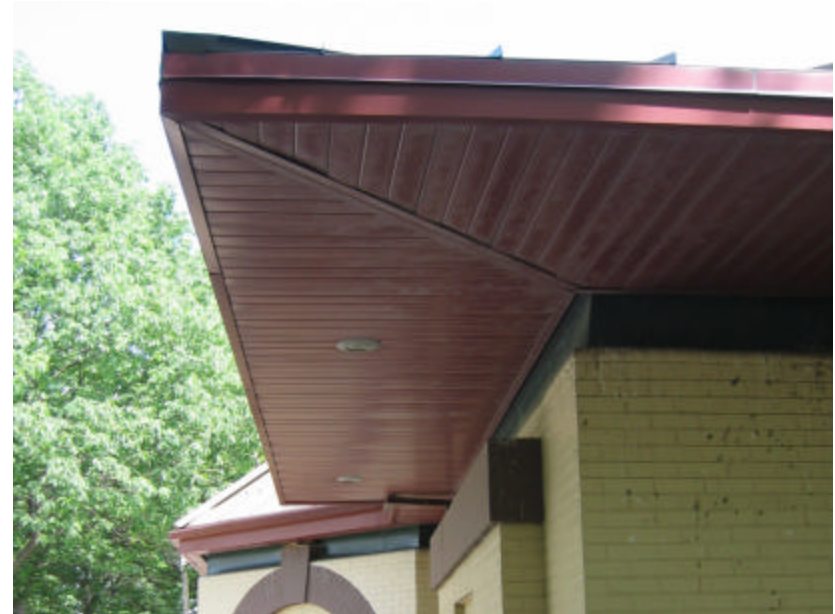
Photo 308
The roof extending over the building; note that it is in good condition.

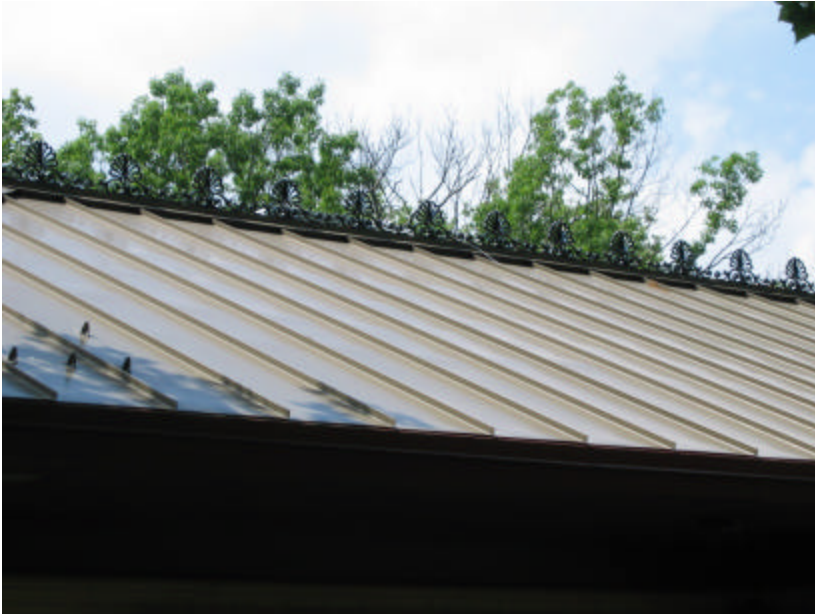
Photo 309
The cresting on the ridge of the roof; note the snow guards on the left.

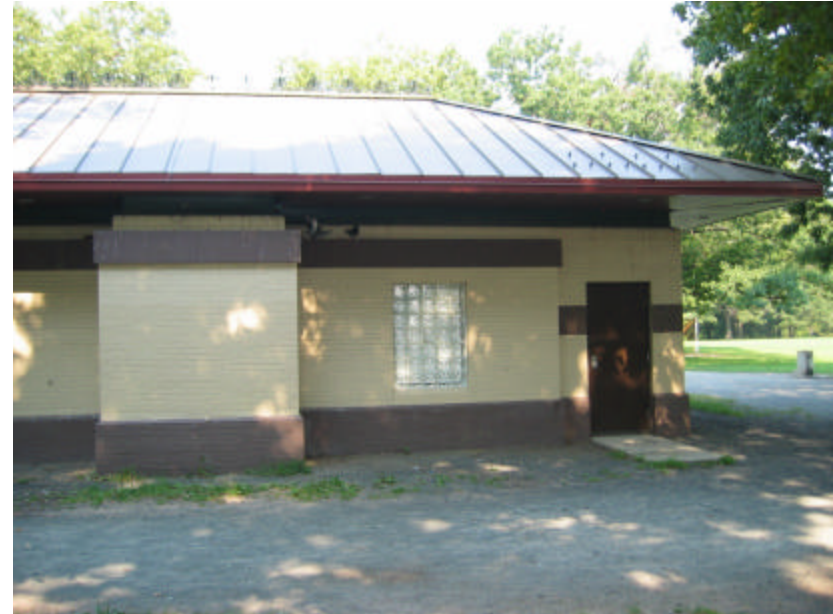
Photo 310
The dark brown concrete belt course; note the pigeons resting on top of it and the areas of staining by bird excrement.

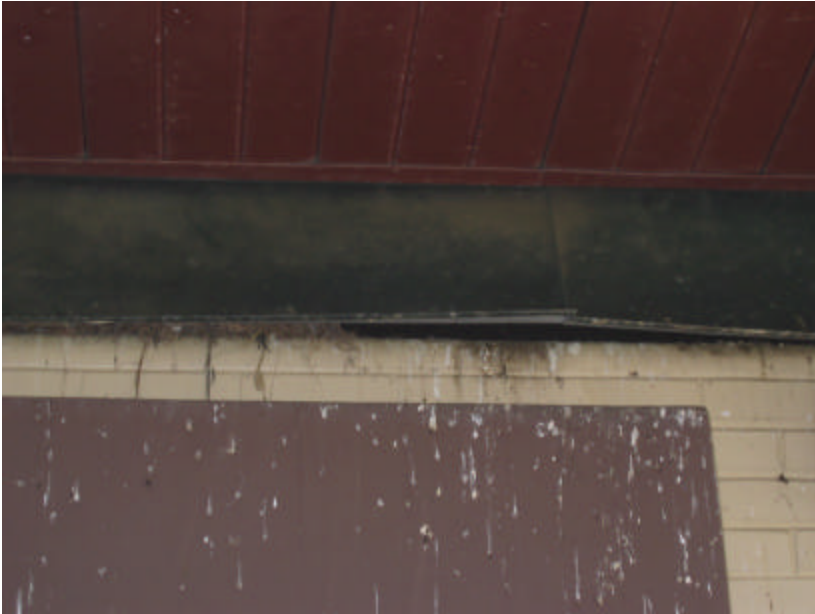
Photo 311
The aluminum cornice on the building's rear has opened; note the bird nests inside and the excrement staining the brick and concrete.

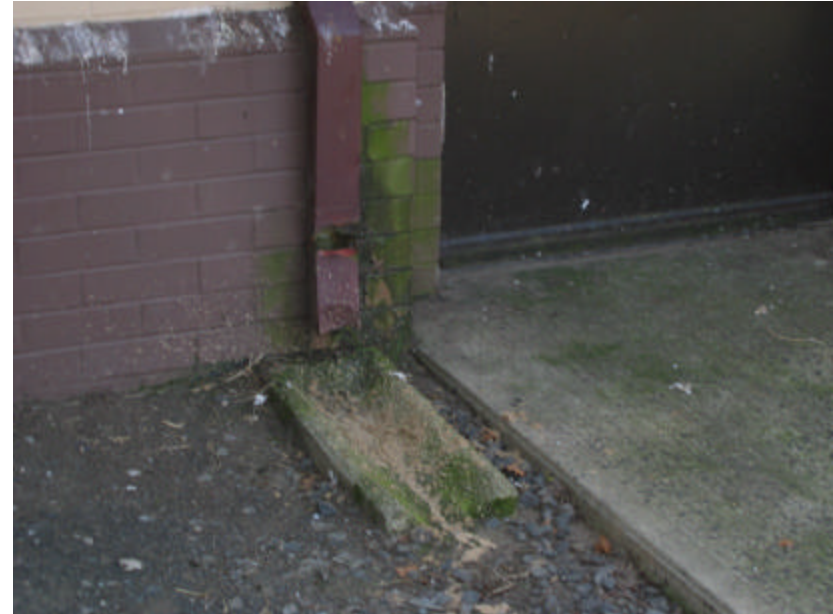
Photo 312
Rusting and damaged downspout; note the organic growth on the bricks.

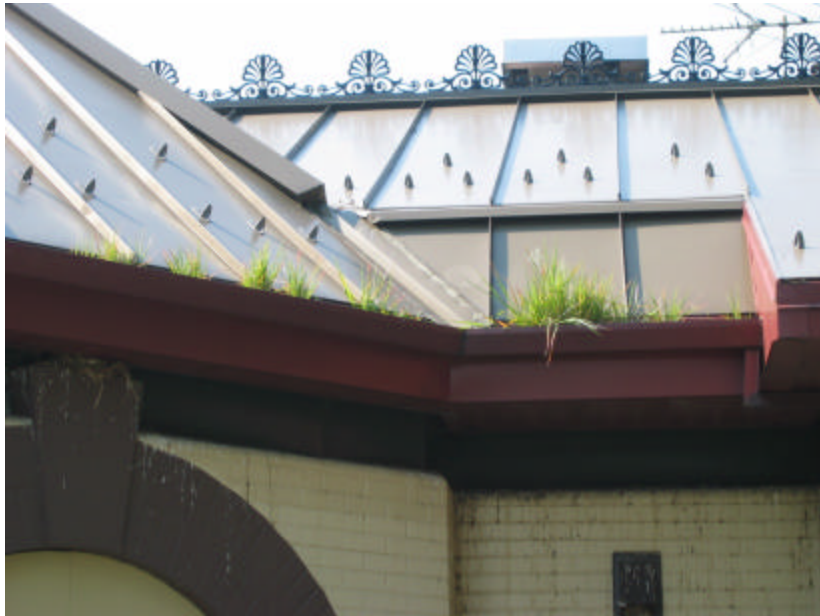
Photo 313
Plants growing in the gutters; note the staining on the bricks.

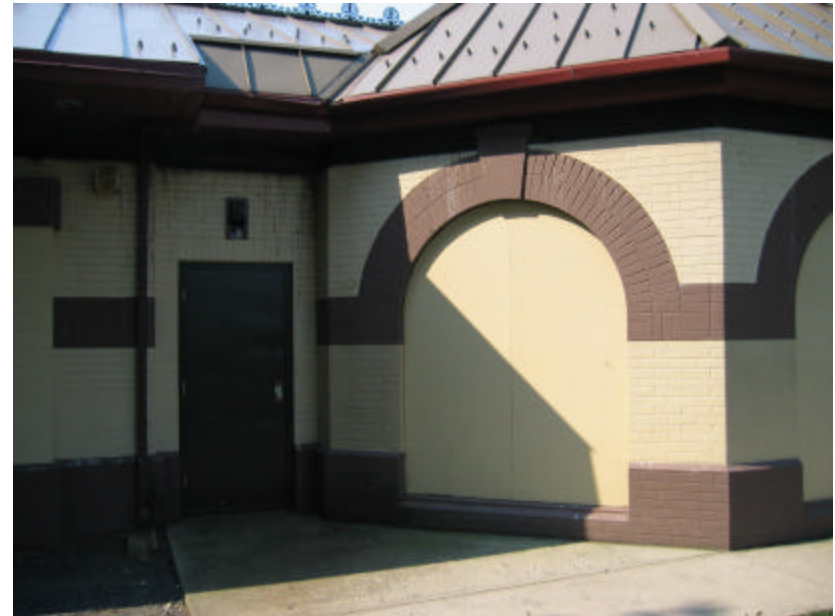
Photo 314
Large arched windows or doorways on the rear of the building; note that they are now covered with plywood.

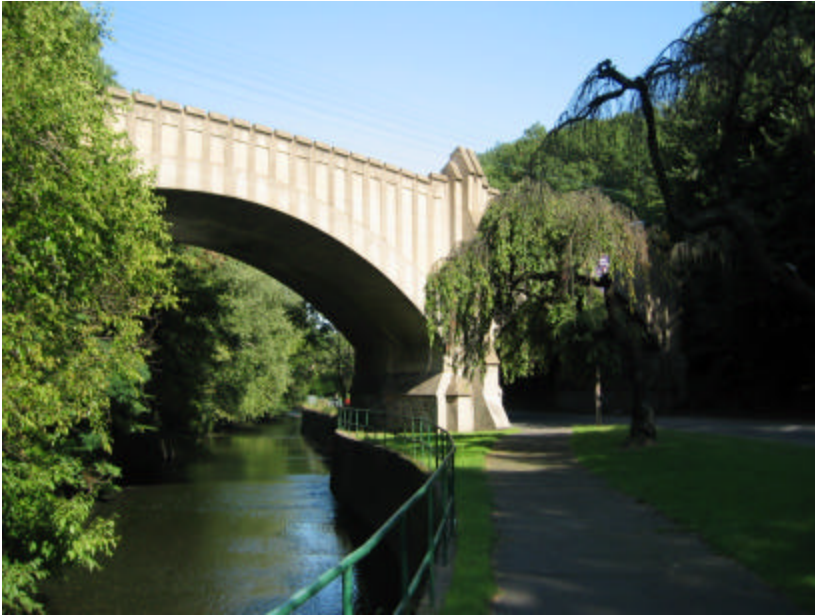
Photo 315
View east towards the bridge; note that this view of the park represents areas that are well maintained.

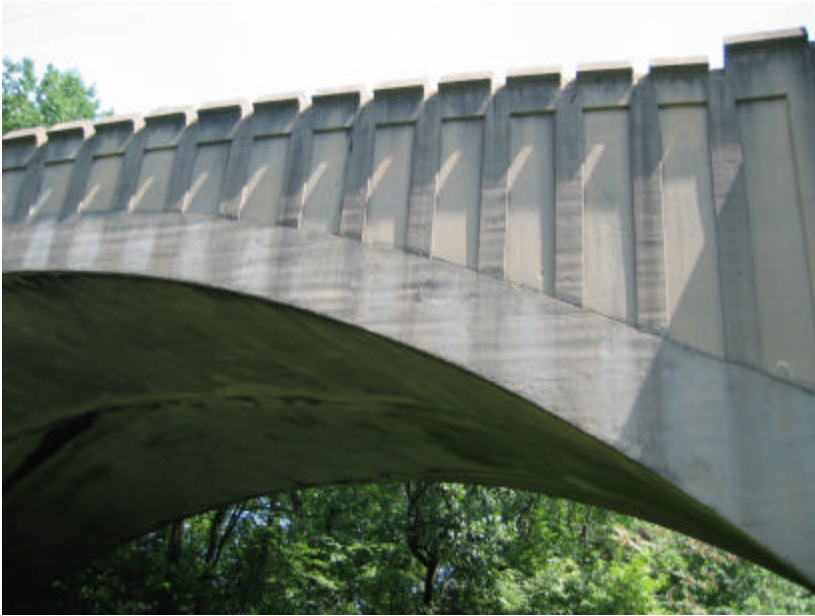
Photo 319
Spalling is visible at the base of many vertical sections; note the crenellated parapet wall.

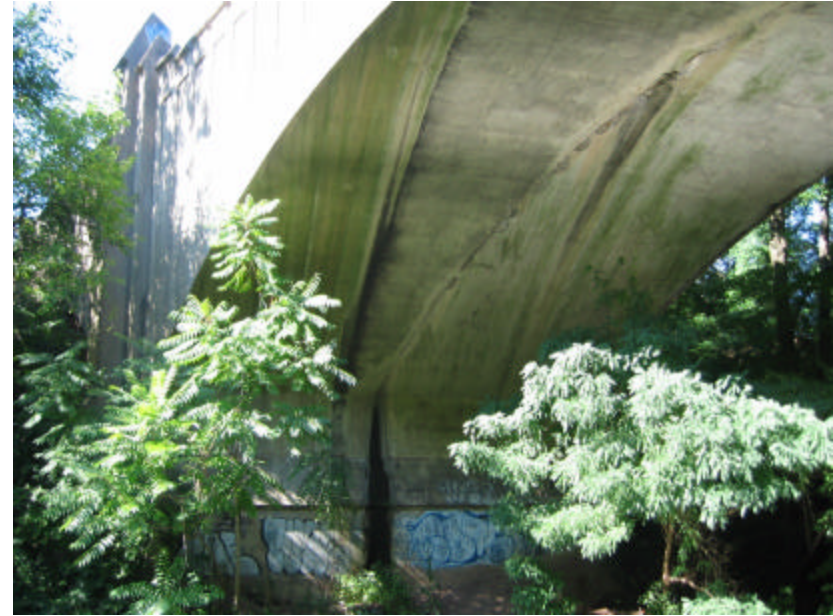
Photo 320
Black staining caused by water damage is visible on the arched span as well as on the foundation caps; note the graffiti and other types of soiling.

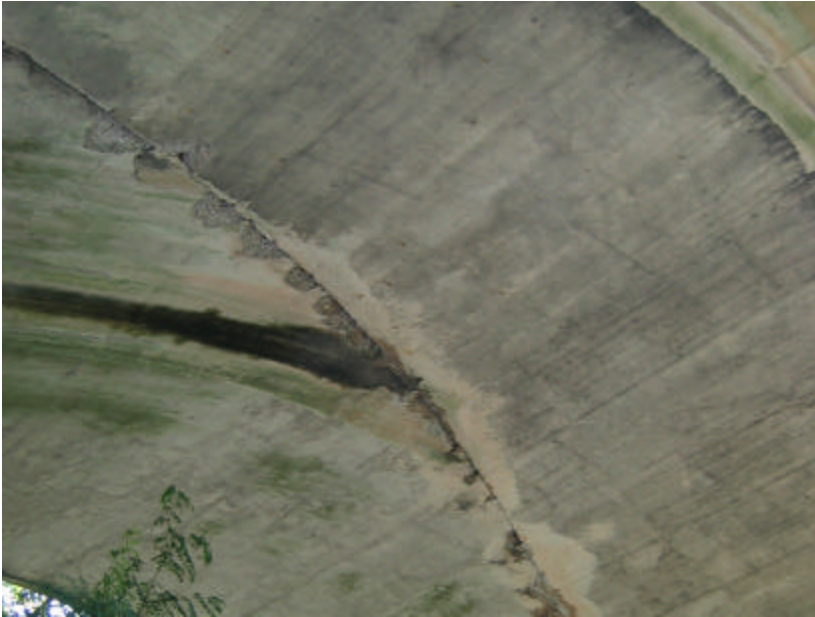
Photo 321
Spalled concrete and water-staining caused by water penetration and the adverse effects of freeze-thaw cycles.

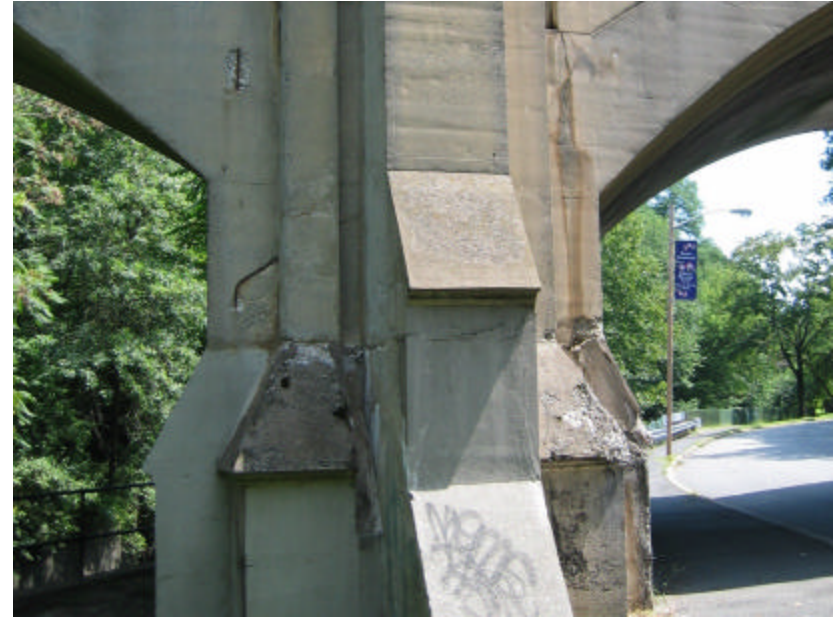
Photo 322
The base of this pier is severely damaged; note the exposed and rusting steel reinforcing in many locations.
